SAFETY INSPECTION REPORT

CONDUCTED FOR:
Thomas James Homes: NorCal

PROJECT:
1949 Laurinda Ave. San Jose

INSPECTION TYPE:
General Construction

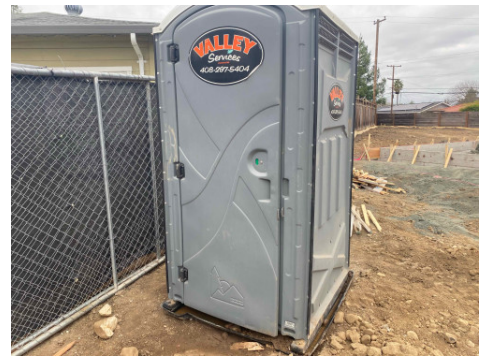
Restrooms **Satisfactory**

Plenty of toilets are located on site and are being kept clean and in good working order.

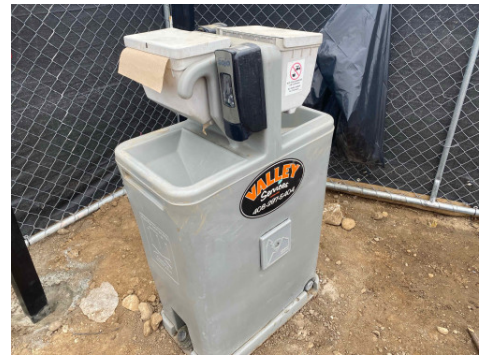
Hand Washing Stations **Satisfactory**

Wash stations are clean and in sanitary condition. There is an adequate supply of soap and paper towels.

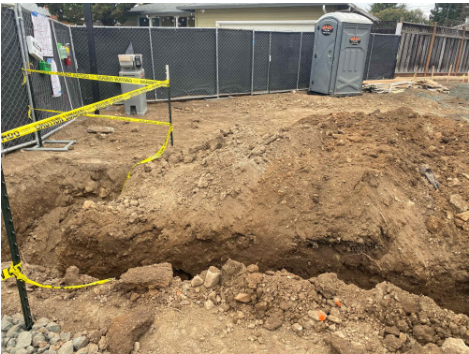
Trenching & Excavation **Unsatisfactory**

Trenches:

- Unmarked trench that poses a trip or fall hazard to workers. A delineation line or cover should be used to protect workers in the area from the hazard.

Comment	Cloverleaf
Delineation lines or covers needed around plumbing trenches. Ensure these are installed.

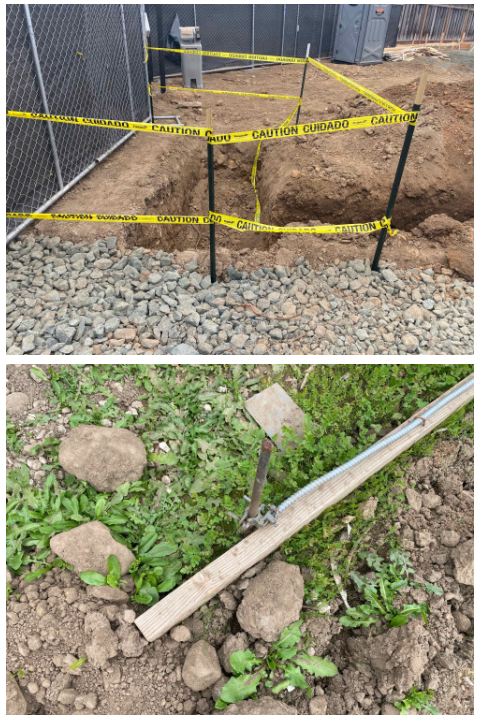
Impalement Hazards	Unsatisfactory
---------------------------	-----------------------

- Green fence posts, rebar and grounding rods are missing protection. Mushroom caps are not approved protection. Ensure protection is put in place. Note: Cal Osha mentions the following: "Protection from Reinforcing Steel and Other Similar Projections. (1) Employees working at grade or at the same surface as exposed protruding reinforcing steel or other similar projections, shall be protected against the hazard of impalement by guarding all exposed ends that extend up to 6 feet above grade or other work surface, with protective covers, or troughs.

Comment	TJHNC
<p>Fence post, and grounding rods pose a hazard. Ensure this is mitigated.</p>

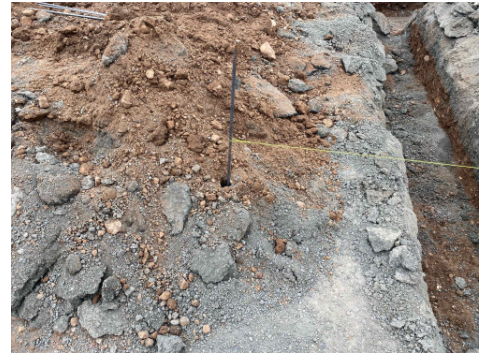
Rebar missing protection. Make sure this is mitigated.

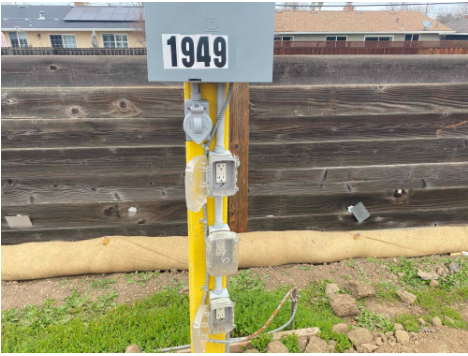
Electrical Safety	Satisfactory
--------------------------	---------------------

Good job having all covers in place.
