# SAFETY INSPECTION REPORT

**CONDUCTED FOR:**  
Thomas James Homes: NorCal

**PROJECT:**  
2114 Coastland Avenue San Jose

**INSPECTION TYPE:**  
General Construction

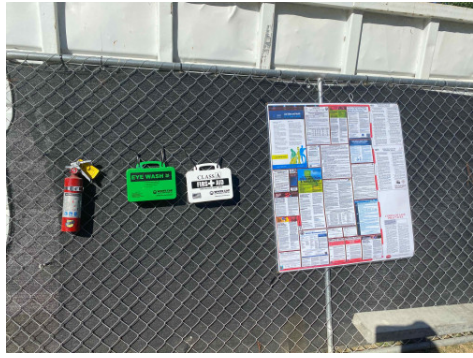
<b>Labor Law Postings</b>	<b>Satisfactory</b>
---------------------------	---------------------

Up on the fence.

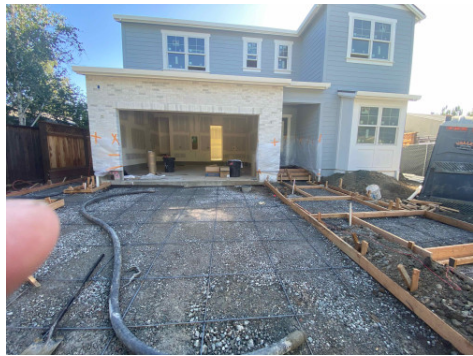
**Access / Egress** **Satisfactory**

Safe access and egress is in place.

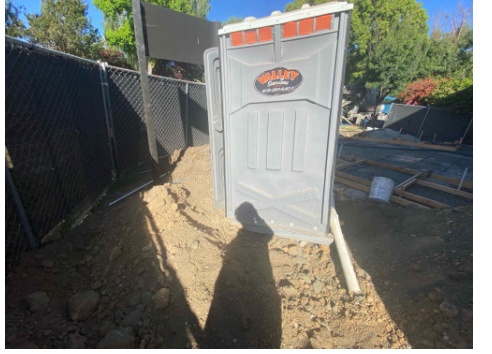
<b>Restrooms</b>	<b>Unsatisfactory</b>
------------------	-----------------------

- Restroom facilities are on unstable ground and the door cannot open. Should be moved so that they can be used.

Comment	
Due to earthwork being done on the site, the restroom facilities has been moved in an unstable location, and the door cannot open completely.

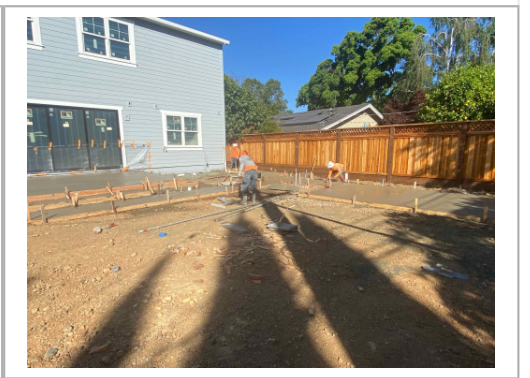
<b>Personal Protective Equipment</b>	<b>Satisfactory</b>
--------------------------------------	---------------------

No concerns observed during the visit.

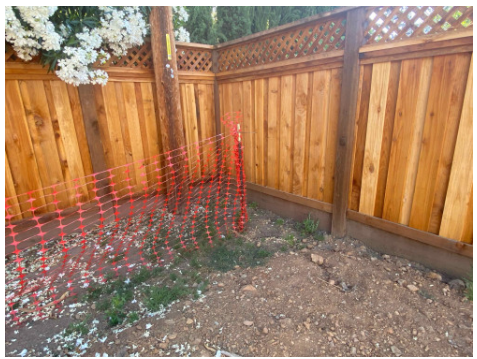
<b>Impalement Hazards</b>	<b>Unsatisfactory</b>
---------------------------	-----------------------

- Green stakes for orange fencing on the property pose an impalement hazard.

Note: Cal Osha mentions the following: "Protection from Reinforcing Steel and Other Similar Projections. (1) Employees working at grade or at the same surface as exposed protruding reinforcing steel or other similar projections, shall be protected against the hazard of impalement by guarding all exposed ends that extend up to 6 feet above grade or other work surface, with protective covers, or troughs.

<b>Comment</b>	
Green fence posts are a hazard. See summary for additional details.

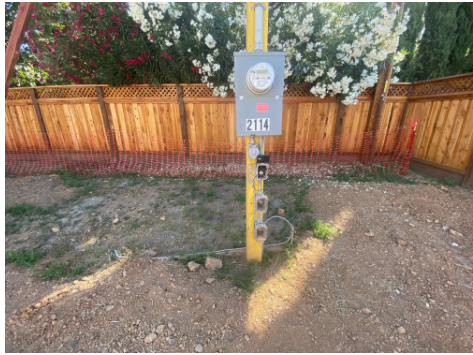
<b>Electrical Safety</b>	<b>Satisfactory</b>
--------------------------	---------------------

<b>Comment</b>	
No concerns observed.

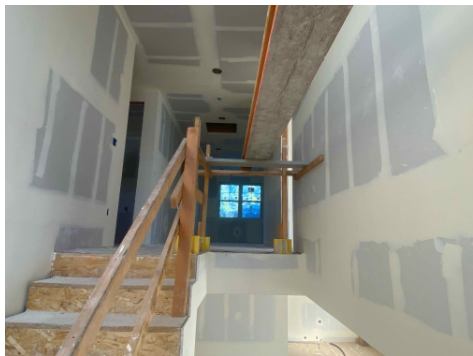
<b>Stairways, Ramps, Runways</b>	<b>Unsatisfactory</b>
----------------------------------	-----------------------

- Ensure guardrails at stairways have a top rail at 42 to 45 inches high and a mid-rail halfway. A mid-rail on site is not installed. Must be capable of withstanding loads of 150lbs.
- Toe-boards missing from the top of the stairway. Toe-boards protect tools and materials from potentially falling below and striking someone. A standard toeboard shall be 4 inches (nominal) minimum in vertical height from its top edge to the level of the floor, platform, runway, or ramp. It shall be securely fastened in place and have not more than 1/4-inch clearance.
- Platform installed using the guard rails of the stairway and a 2 x 4 attached to the wall. This is an illegal platform. It is believed to be there from the drywall finishers. Ensure the subcontractor is made aware that this is not approved and should never happen on the Thomas James homes site.

<b>Comment</b>	
Mid rail and toe-board missing from stairway. See summary for additional details.

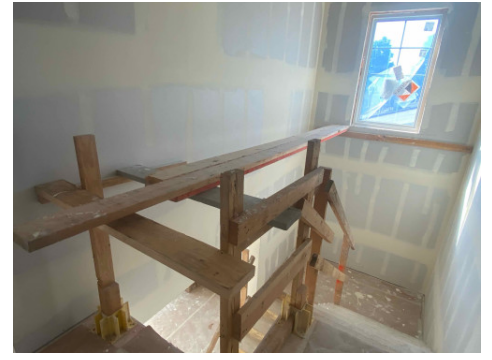
Makeshift platform added to the top of the stairwell. This is a greater than 7 1/2 feet fall hazard. This is not allowed. It is unclear which subcontractor put this year because it was not being used and no one was working on the interior of the house at the time. However, it is suspected this is that this is related to drywall finishing.
