# SAFETY INSPECTION REPORT

**CONDUCTED FOR:**  
Thomas James Homes: NorCal

**PROJECT:**  
521 Minnesota Ave San Jose

**INSPECTION TYPE:**  
General Construction

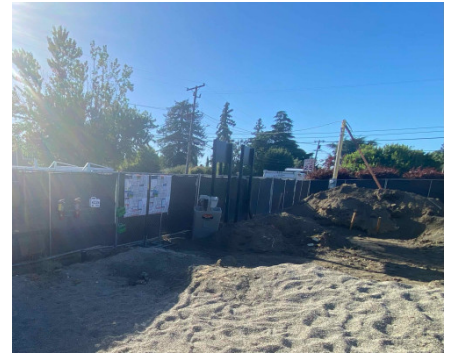
**Labor Law Postings** **Satisfactory**

Good job having these posted.

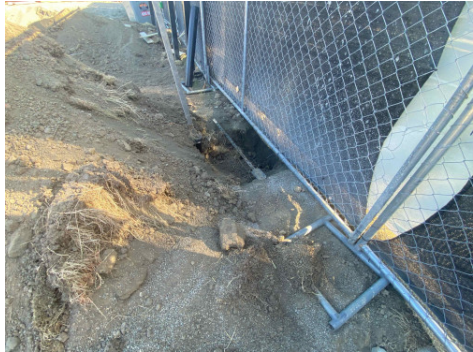
<b>Trenching &amp; Excavation</b>	<b>Unsatisfactory</b>
-----------------------------------	-----------------------

- Open hole of 2 feet depth with a width of approximately 3 feet. Delineation lines should be used identify hazard and/or a cover.

<b>Comment</b>	
Unmarked hole at the front of the site is a trip and fall hazard. See summary for additional details.

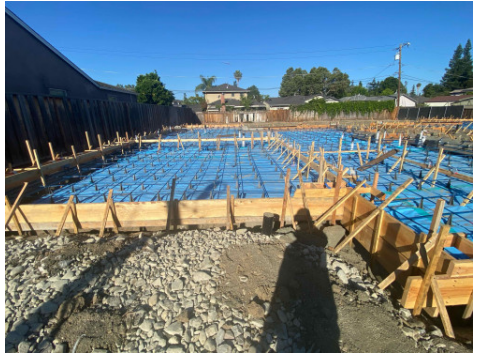
<b>Impalement Hazards</b>	<b>Unsatisfactory</b>
---------------------------	-----------------------

- Anchor bolts in the forms pose an impalement hazard.

Note: Cal Osha mentions the following: "Protection from Reinforcing Steel and Other Similar Projections. (1) Employees working at grade or at the same surface as exposed protruding reinforcing steel or other similar projections, shall be protected against the hazard of impalement by guarding all exposed ends that extend up to 6 feet above grade or other work surface, with protective covers, or troughs.

<b>Comment</b>	
Anchor bolts in the forms are an impalement hazard. Cap should be added to mitigate.

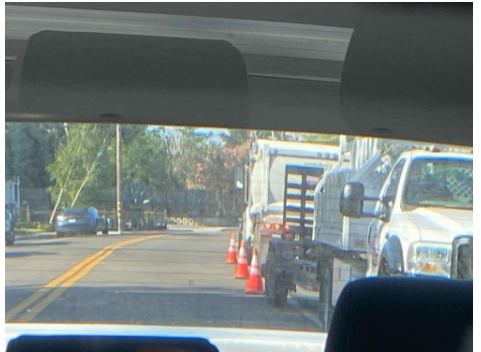
<b>Traffic Control</b>	<b>Satisfactory</b>
------------------------	---------------------

<b>Comment</b>	
Good traffic control is in place on the street for parked equipment.

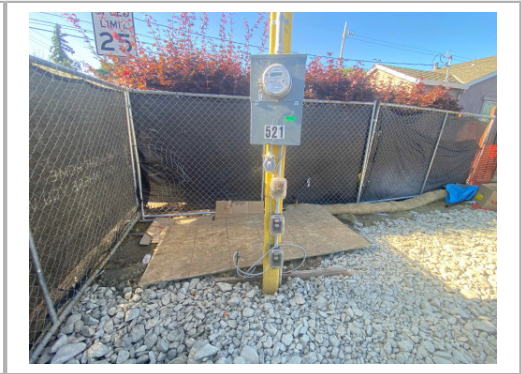
<b>Electrical Safety</b>	<b>Satisfactory</b>
--------------------------	---------------------

Good job having all covers in place.
