# SAFETY INSPECTION REPORT

**CONDUCTED FOR:**  
UC Construction

**PROJECT:**  
stoneridge West

**INSPECTOR :** ESPITIA GUS  
**DATE :** OCTOBER 15, 2024  
**CITY :** MERCED  
**STATE :** CA.

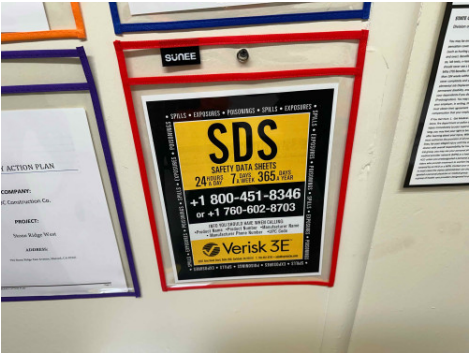
<p>SDS are available for employee access</p>

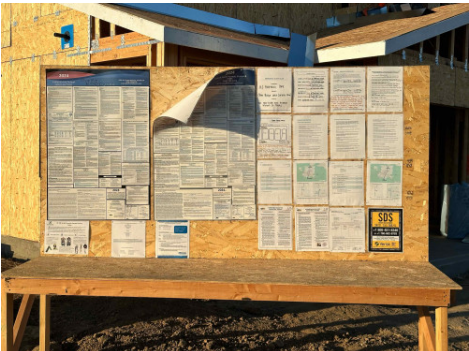
<p><b>Comment</b></p>	
<p>Labor law postings are in place as required.</p>

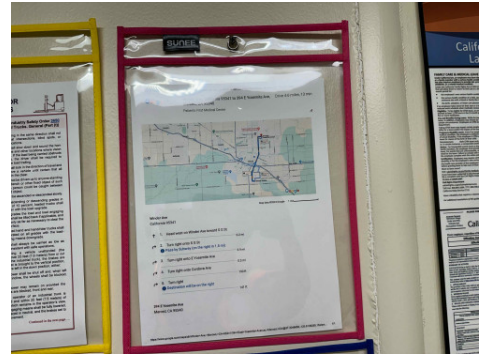
Emergency posters are on site and directions to nearest medical facility are posted.

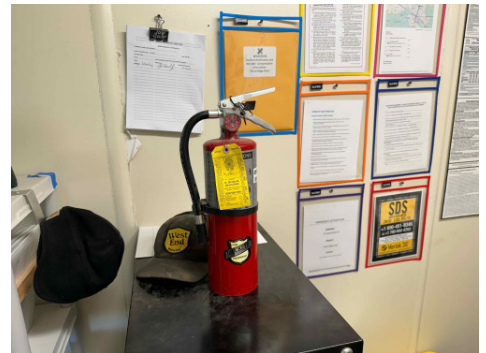
Fire extinguisher is available on site

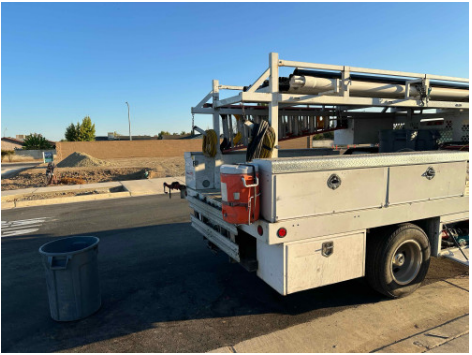
<p>There is drinking water available on site</p>

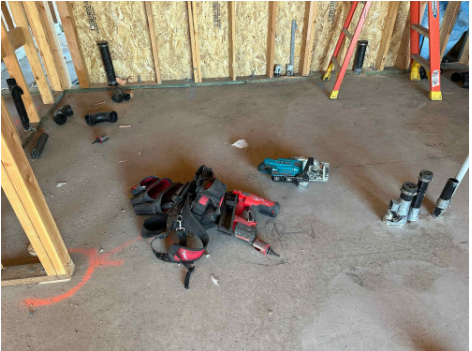
<p><b>Power Tools</b></p>	<p><b>Satisfactory</b></p>
<p><b>Comment</b></p>	
<p>Power tools are good working condition</p>

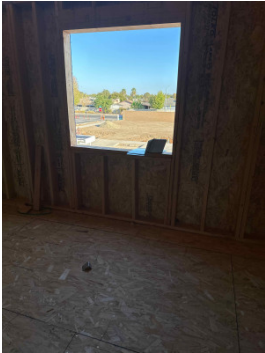
<b>Guardrails</b>		<b>Unsatisfactory</b>
<b>Comment</b>		
The second story windows bottom base is 35 inches from floor. It needs a top rail installed at 42 inches to 45 inches high.

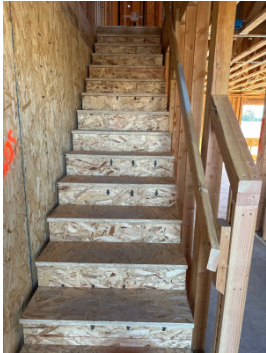
<b>Comment</b>	
Hand rails are in place
