# SAFETY INSPECTION REPORT

**CONDUCTED FOR:**  
West Builders, Inc.

**PROJECT:**  
Fullerton HUB

**INSPECTION TYPE:**  
General Construction

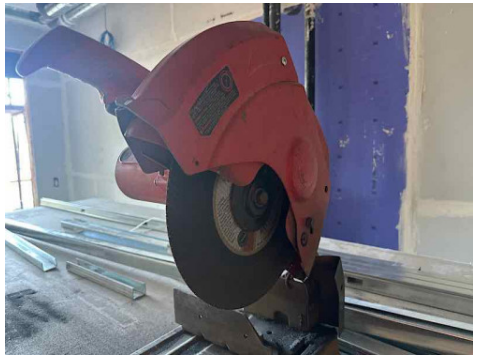
<b>Power Tools</b>	<b>Unsatisfactory</b>
--------------------	-----------------------

Comment	
<p>Sharp has a chop saw with the guard screwed up. The guard must be operational at all times. The workers must remove the screw.</p>

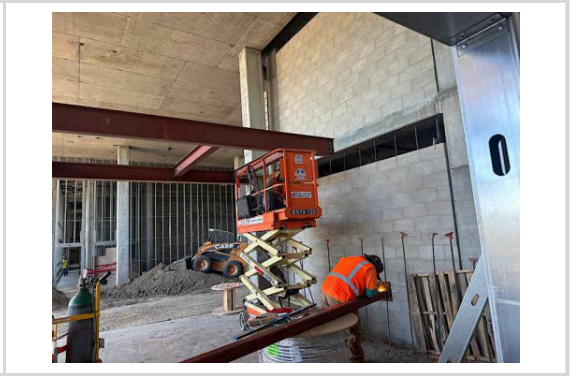
<b>Mobile Elevated Work Platforms (MEWP's)</b>	<b>Unsatisfactory</b>
--	-----------------------

JEM worker did not have safety chains secured. The worker secured the chain immediately. In addition, the workers are using the lift to hoist/support the steel. This is prohibited. The workers complied to use the forklift.

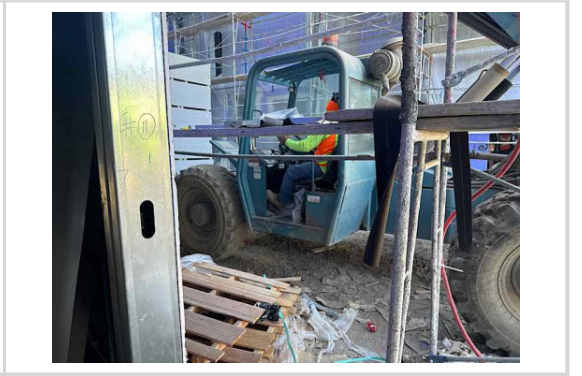
<b>Powered Industrial Trucks</b>	<b>Unsatisfactory</b>
----------------------------------	-----------------------

Sharp worker is operating the forklift without his seat belt secured. The worker secured his seat belt immediately.

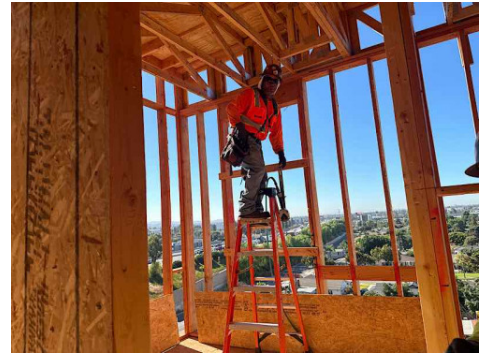
<b>Ladders</b>	<b>Unsatisfactory</b>
----------------	-----------------------

Trademark worker is straddling the top of the A Frame ladder. This is prohibited. The worker was recommended to use a larger ladder.

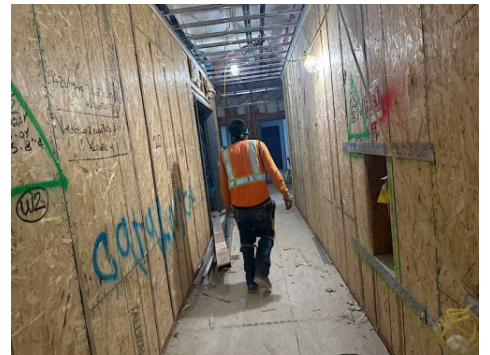
Some workers are observed without required PPE including hard hats and safety glasses.

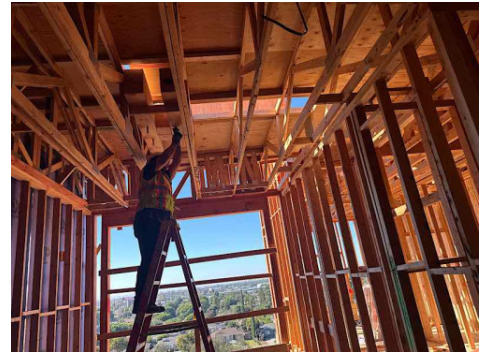
Lynn Safety worker needs safety glasses and complied to don them.

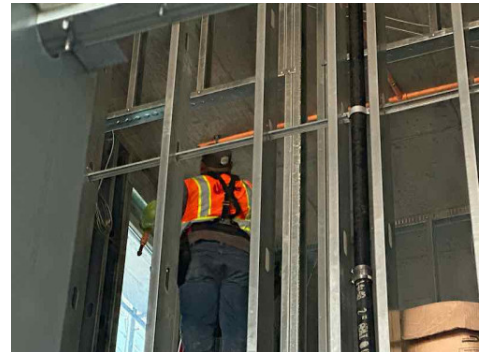
Miller worker is missing his hard hat while working. The worker was reminded and complied to don his hard hat immediately.

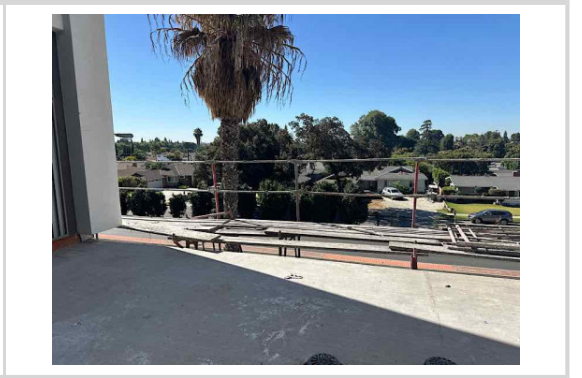
**Fall Protection** **Unsatisfactory**

The scaffold section is providing a catch platform for the balcony. However, the platform must have a 2x6 toe board to qualify as fall protection.

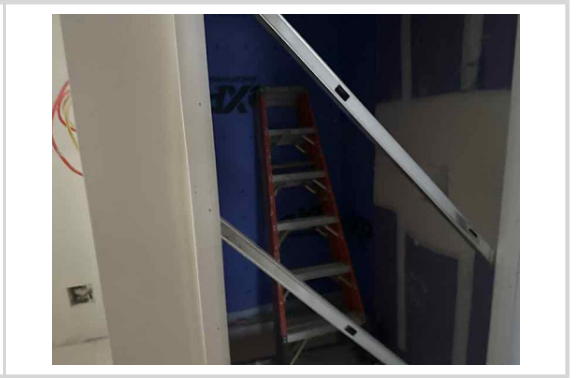
**Guardrails** **Unsatisfactory**

Ladder is observed behind the guard rails in a shaft. Workers must have personal fall protection when exposed to a hole 12" or greater.

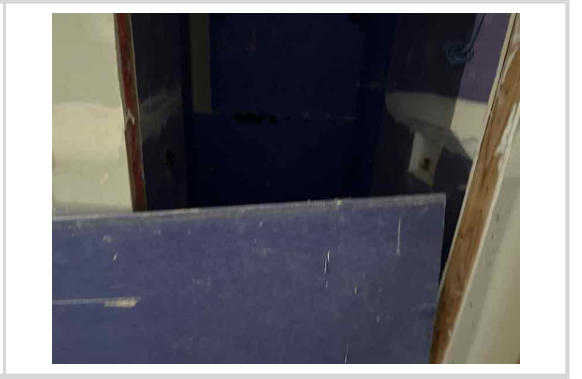
Shaft protection has been removed and left loose. The shaft must be protected at all times.

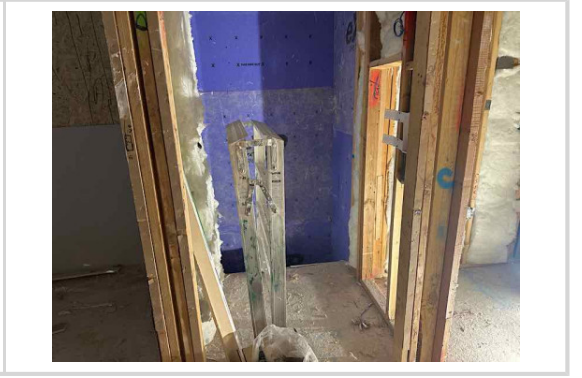
Sharpe workers are working exposed to the open shaft. Fall protection is required. Sharp must have a fall protection plan written and implemented for open shafts. Workers here complied to add guard rails.

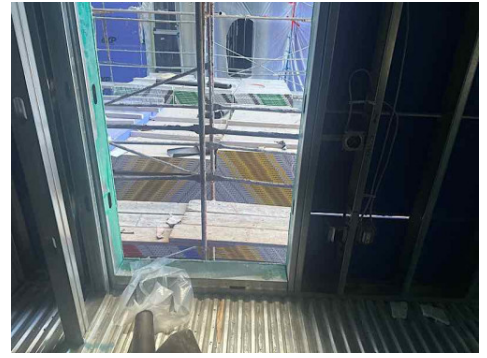
Please ensure all window openings on the mezzanine level are protected with guard rails. This opening is unprotected.

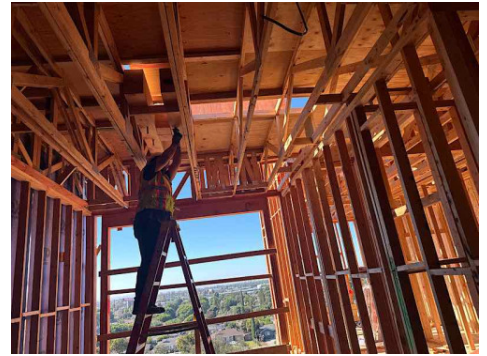
**Floor / Wall Openings**

Lynn Safety worker on the roof has removed the plywood over the opening. The worker was recommended to return the plywood with a small space for passing materials. The workers complied.

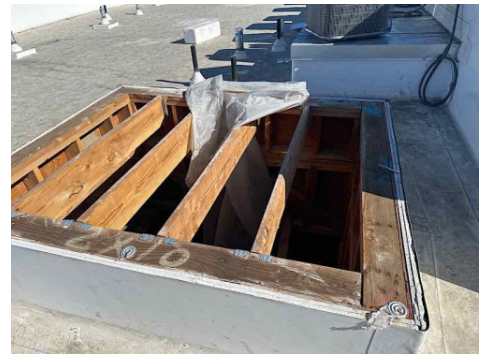
On the roof of building A, a roof opening is missing the cover and is open. Please ensure that all open shafts are covered, secured and marked, Opening, Do Not Remove.

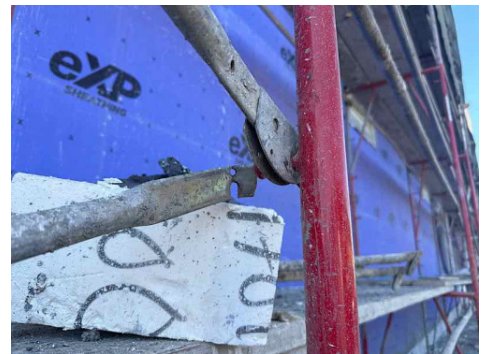
**Supported Scaffolding**

It is observed on the bottom of an end section, the cross brace is damaged and unsecured. All items must be inspected by the contractors using the scaffold and a competent person must make corrections.

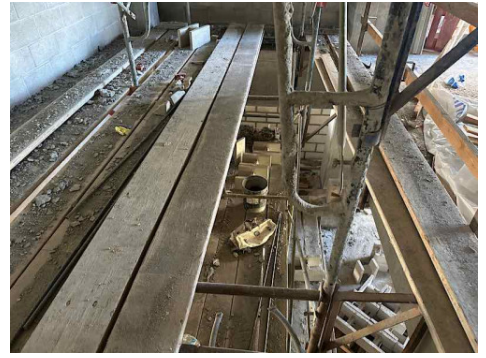
Guy Yocom scaffold in stairwell is missing planks with open gaps to the level below. Please ensure all working levels are fully planked.

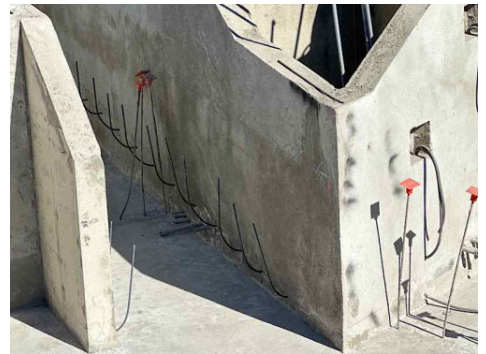
**Impalement Hazards**

Guy Yocom has some vertical rebar that must be protected with osha approved caps. Please ensure all vertical rebar is protected.

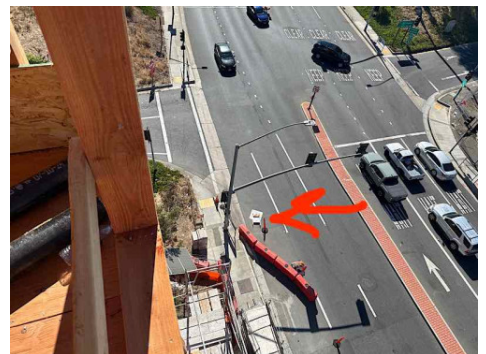
**Traffic Control**

Please ensure all traffic signs are erected and communicate clear directions.

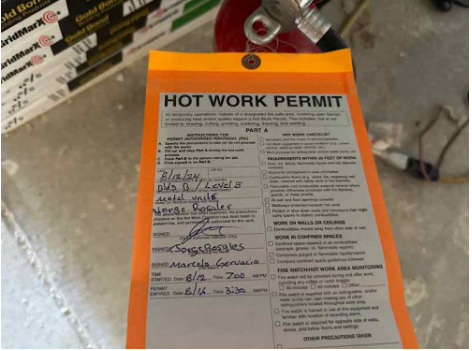
**Hot Work** **Unsatisfactory**

Comment	
<p>Sharp has a hot work permit that is expired. Please ensure all hot work permits are up to date.</p>

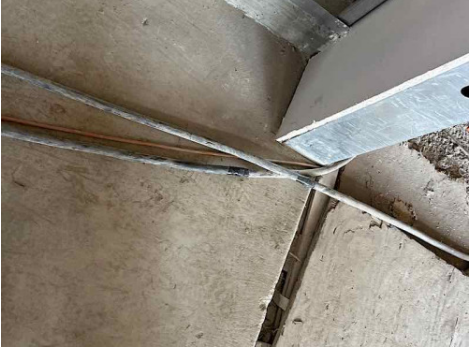
**Electrical Safety** **Unsatisfactory**

Comment	
<p>The temporary power cables have damaged insulation. The the temp power must be inspected monthly. Any cables with damaged should be removed or replaced.</p>

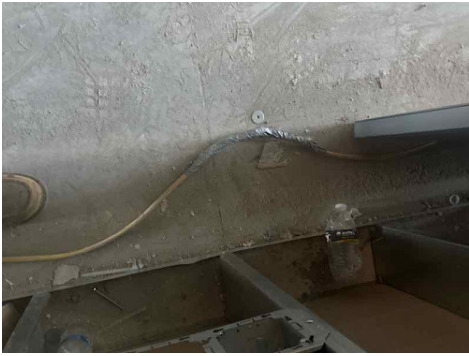
Rye has an electrical cord with damaged insulation. The cord must be removed and replaced. The workers complied to remove the cord immediately.

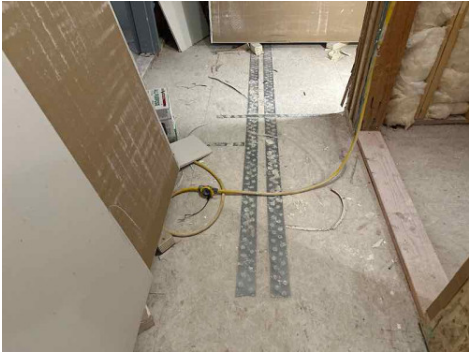
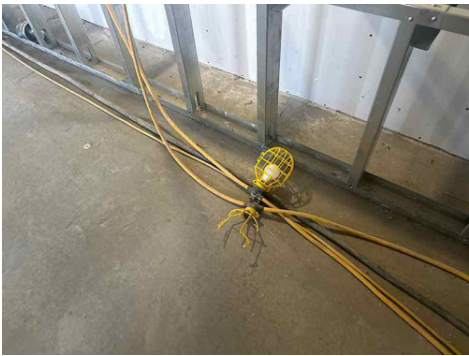
There are several bulbs missing from light strings. Light strings must be inspected regularly to ensure all bulbs or manufactured caps are in place to eliminate any shock exposures.

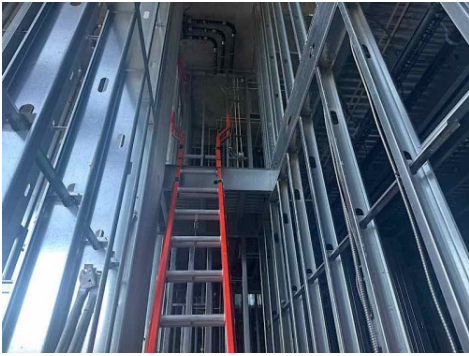
**Stairways, Ramps, Runways** **Unsatisfactory**

Floors must have stair ways leading to the floor once walls are erected. Stairs should be installed for the mezzanine level.
