# **SAFETY INSPECTION REPORT**

**CONDUCTED FOR:** West Builders, Inc.

### **PROJECT:** Fullerton HUB

**INSPECTION TYPE:** General Construction

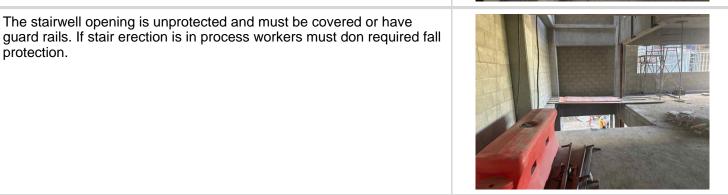
Please ensure two guard rails are erected where required. Here at the south east stairwell in the parking garage on the second (mezzanine) level, only one rail is posted. Guard rails must be erected at 42/21".

The stairwell opening is unprotected and must be covered or have

The door opening on the mezzanine level must have fall protection. In addition the scaffold that is greater than 16" from the structure (on the other side of the doorway) must have inside guard rails. Please ensure
