SAFETY INSPECTION REPORT

CONDUCTED FOR:
West Builders, Inc.

PROJECT:
Fullerton HUB

INSPECTION TYPE:
General Construction

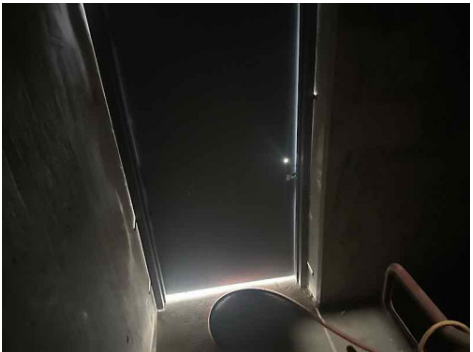
The exit door at the bottom of the east stairs from the structure is locked from the outside. This should be open while workers may use this as an exit.

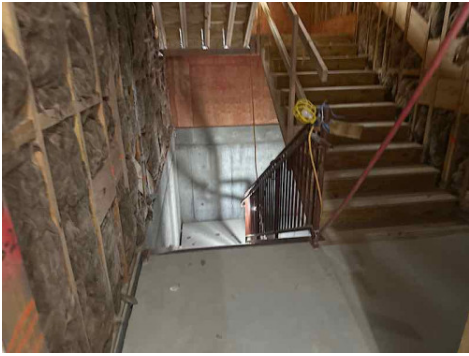
If the door must be secured the stairway should be closed and signage should be posted.

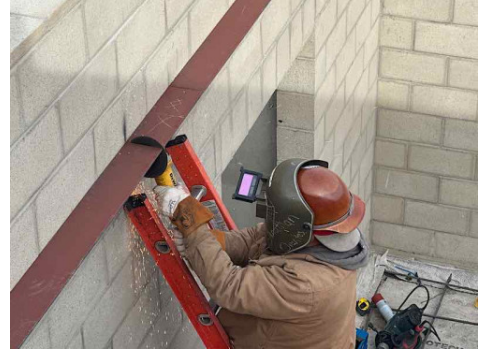
Steel worker has a grinder with the guard removed. All manufacturer's safety elements must be in place at all times. The worker replaced the guard immediately.

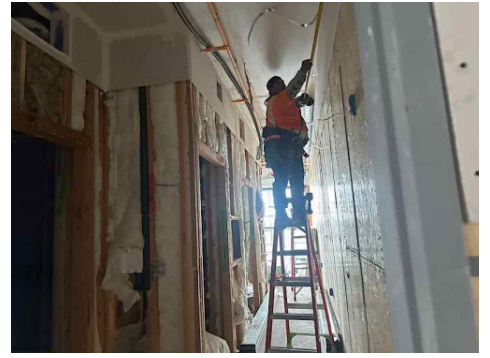
Atlas worker is standing on the second to last rung of the A frame. The worker was recommended to use a larger ladder. In addition he donned his hard hat.

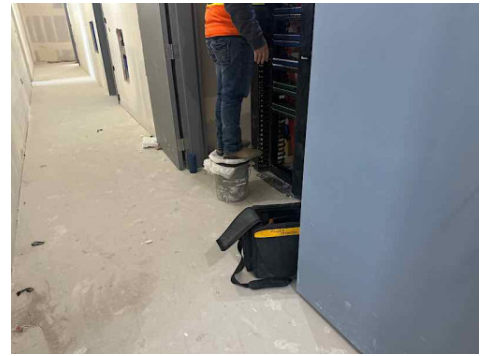
A worker is observed gaining elevation by standing on a bucket. The worker was notified that a properly manufactured ladder or scaffold must be used. The worker stapled off of the bucket.

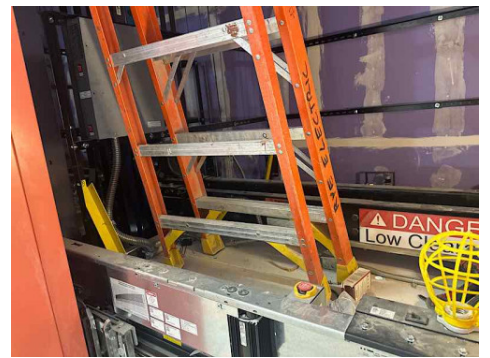
Rye workers have leaned A frame ladders above the elevators. A Lean Safe or Extension ladder should be used.

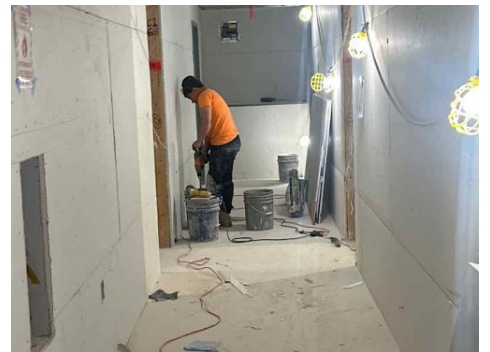
Tile worker is observed without required PPE. While mixing eye protection should be donned. Also, when coming out of a unit that does not have over head hazards, hard hats must be donned. The worker was reminded of the PPE requirements.

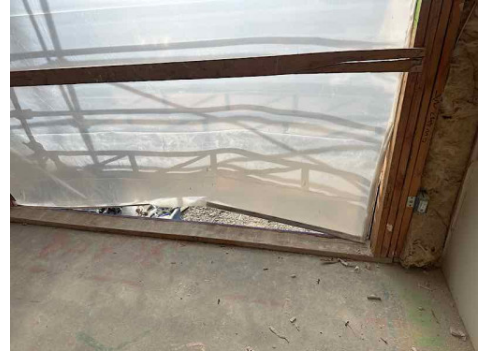
A window opening in 249 is observed with only one rail. Please ensure standard rails are setup at 42/21”.

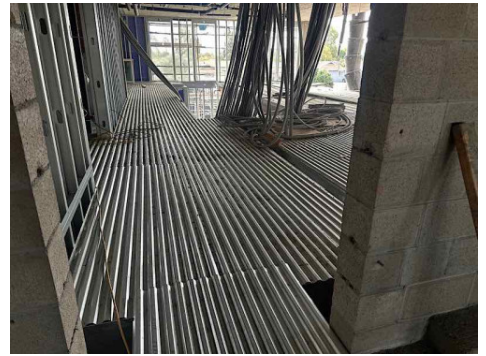
The mezzanine in D/E has an unprotected edge. Please ensure this area is closed or protected with guard rails.

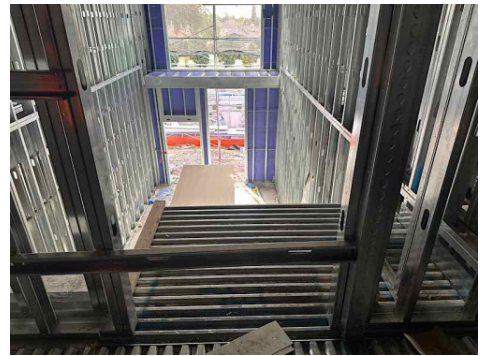
Workers have removed a top rail on the mezzanine section where they are working. Workers were notified all guard rails must be in place.

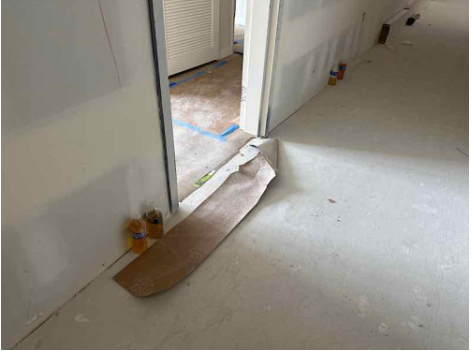
Comment	
<p>Bottles of urine are observed in hallways. Please ensure all contractors are notified of the unsanitary condition this introduces into the work site. Restrooms should be used. There has been an improvement on the cleanliness of restrooms and all workers onsite are responsible for maintaining sanitary conditions.</p>

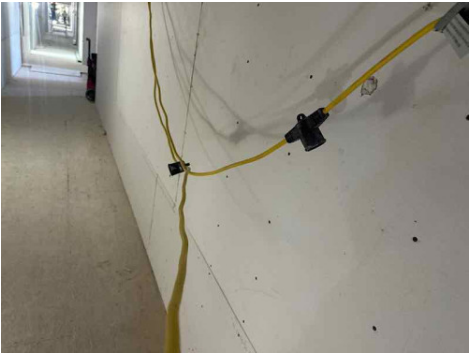
<p>Bulbs are missing from some light strings. Most lights are in place however please ensure these are inspected and missing bulbs are covered or replaced.</p>

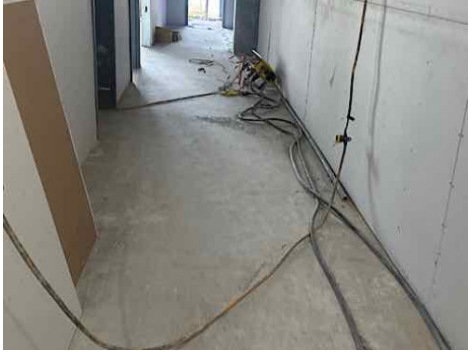
<p>One light is missing and the cord is damaged. This cord should be replaced.</p>

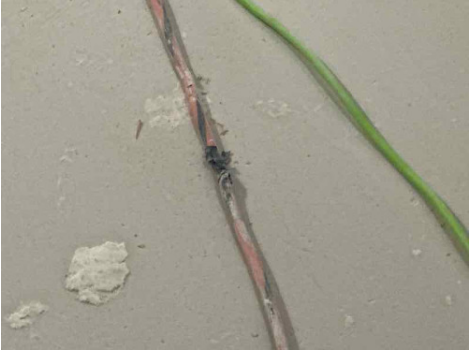
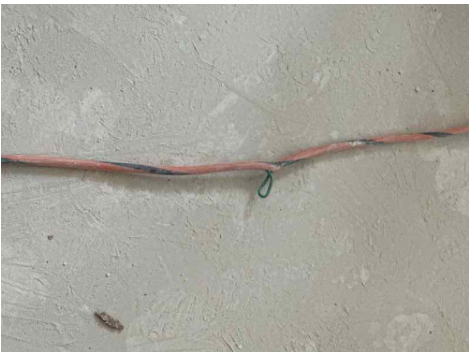
<p>Sharp has a few cords that are damaged. Please ensure all cords are inspected and removed from service.</p>
