# SAFETY INSPECTION REPORT

**PROJECT:**  
Fullerton HUB

**INSPECTION TYPE:**  
General Construction

**INSPECTOR :** JUSTYN BLANCHARD  
**DATE :** JANUARY 06, 2025  
**CITY :** FULLERTON  
**STATE :** CA

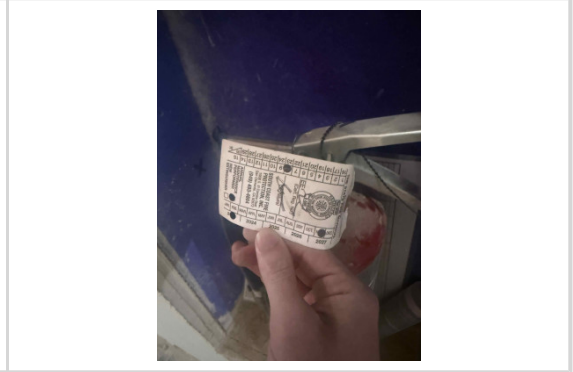
Fire extinguishers throughout the site are 2 months past its annual inspection. Please swap out or have these fire extinguishers serviced.

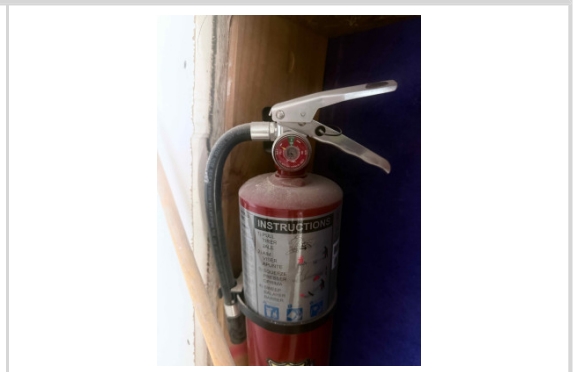
4th floor fire extinguisher is not properly charged and needs to be replaced.

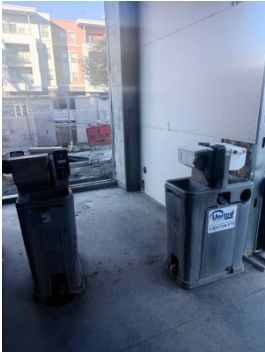
<b>Hand Washing Stations</b>	<b>Unsatisfactory</b>
<b>Comment</b>	
Wash stations do not have paper towels or soap. This needs to be restocked.

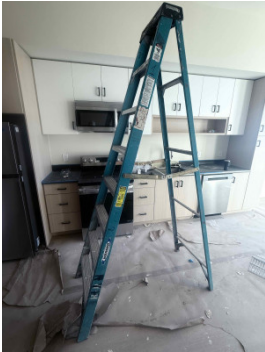
<b>Ladders</b>		<b>Unsatisfactory</b>
<b>Comment</b>		
RYE - Ladder in unit 214 ladder is unstable and needs to be replaced.

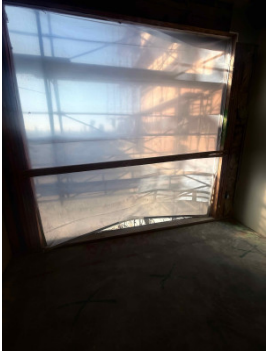
<p>Unit 249 - railing is damaged and also a mid rail is needed.</p>

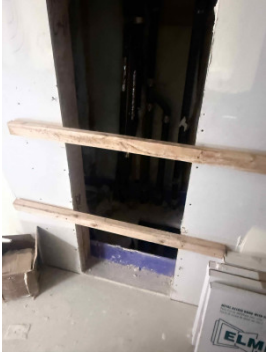
<p>Top rail is set at 45" with a mid rail half way. No hazards seen.</p>

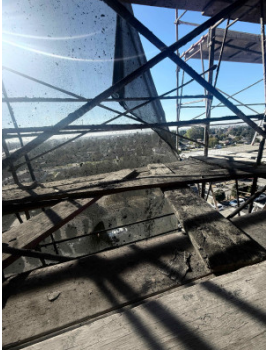
<p>Recurring issue - Unit 568 - The scaffold has sections connecting to the patios built up with planks. However the gaps exceed 1" in the working platform. Please ensure either the working level is fully planked or the a ramp with guard rails connects the level between the outer scaffold and the balcony scaffold.</p>

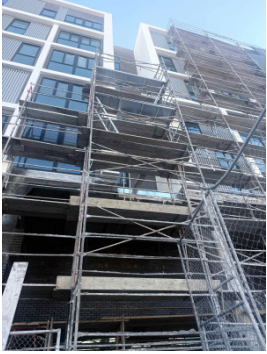
<p>Ensure that toe boards are on each level above entry/exit ways.</p>

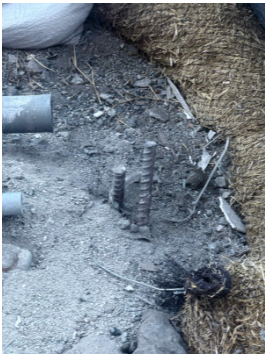
<b>Comment</b>	
Ensure that all impalement hazards are capped on site.

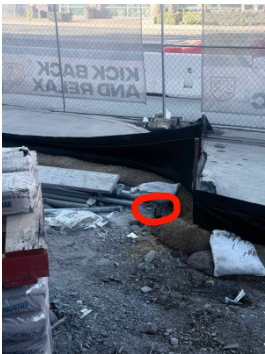
Another photo of the rebar that needs to be capped. This is by the entrance.

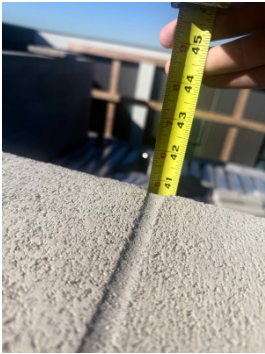
<p>Up on the 6th near the pool area, there is a ladder leading up to the roof where the parapet wall is 41". If roofers are working here, they don't need fall protection since they can work near parapet walls that are 24". If it is any other trade, they are exposed to a fall greater than 7 1/2 feet and either need fall protection or railing installed.</p>

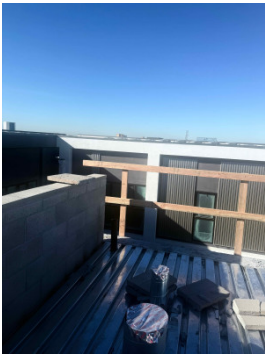
<p>Railing on this same roof is installed properly.</p>

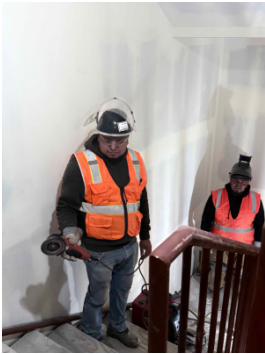
<p>Hot work procedures were seen being followed properly.</p>

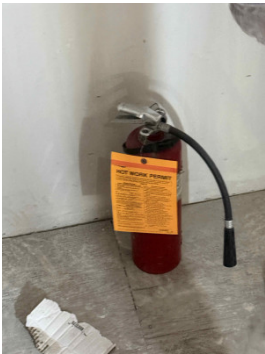
<p>Hot work permit is being filled out as needed.</p>

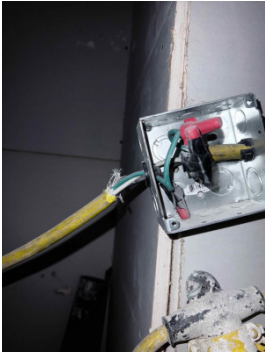
<b>Comment</b>	
<p>Near unit 249 - Cable has exposed wiring and needs to be replaced. Also this electrical box needs to be enclosed.</p>

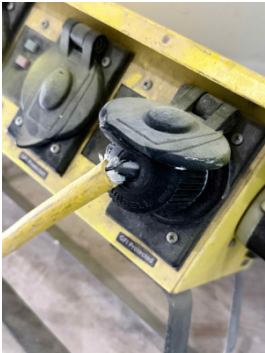
<p>Unit 357 - another cable with exposed wiring.</p>

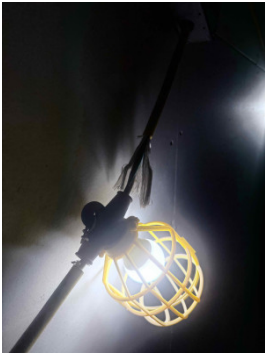
<p>4th floor light cables are very damaged and needs to be replaced.</p>

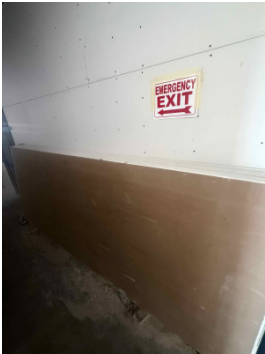
<p>Please see the CAL/OSHA code to securing materials leaned on its side - 1549 Piling Materials - (d) Sheetrock, plywood, trusses, and similar material shall not be stacked on edge unless positively secured against tipping or falling.</p>
