SAFETY INSPECTION REPORT

CONDUCTED FOR:
W.L. Butler Construction, Inc.

PROJECT:
Costco (Napa)

INSPECTOR : JOSHUA JOHNSON
DATE : AUGUST 29, 2024
CITY : NAPA
STATE : CA

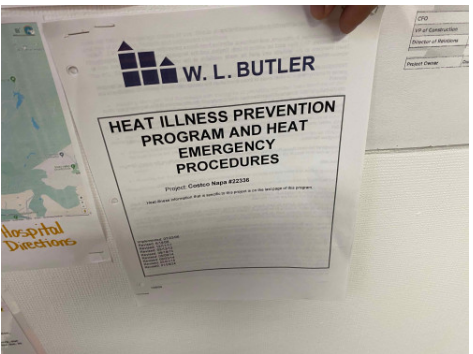
Heat Illness Prevention Program	Satisfactory
Comment	
Good job having this available on site.

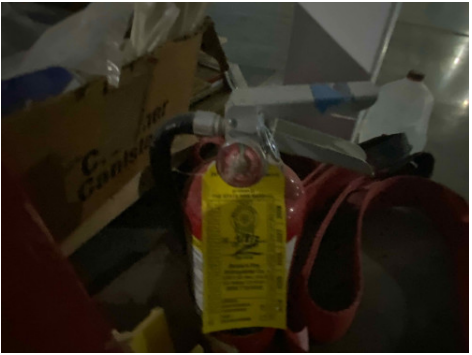
Fire Extinguisher(s)	Satisfactory
Comment

<p>Good job having plenty of extinguishers on site.</p>

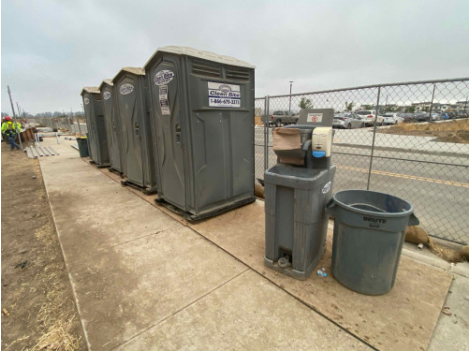
<p>Restrooms Satisfactory</p>	
<p style="text-align: center;">Comment</p>	
<p>Good job having restrooms in place.</p>

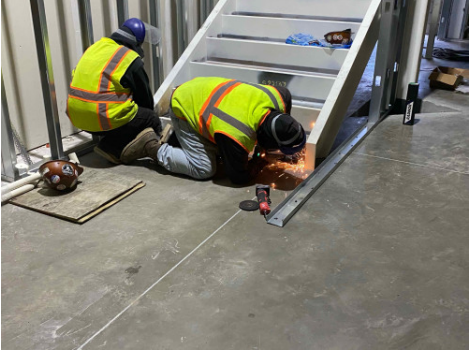
- Grinder missing necessary guards. Guards should never be removed, even if it seems needed to perform the work. Removing guard and using the tool is against manufacturers instruction and could result in a cut or amputation. Corrected on site.

Power Tools	Unsatisfactory
Comment	
<p>Worker using a grinder without a guard. Corrected on site.</p> <p>See additional comments under hot work.</p>

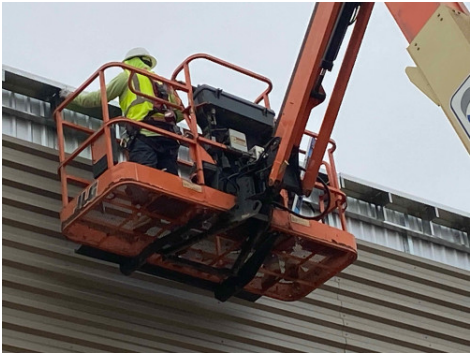
Mobile Elevated Work Platforms (MEWP's)	Satisfactory
Comment

No concerns observed.

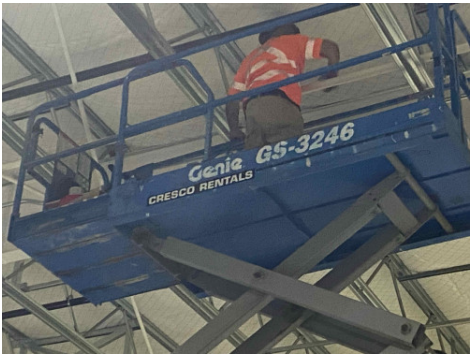
Safe use observed.

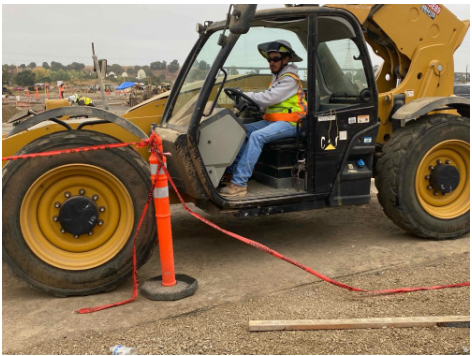
Powered Industrial Trucks **Satisfactory**

Good job wearing your safety belt!

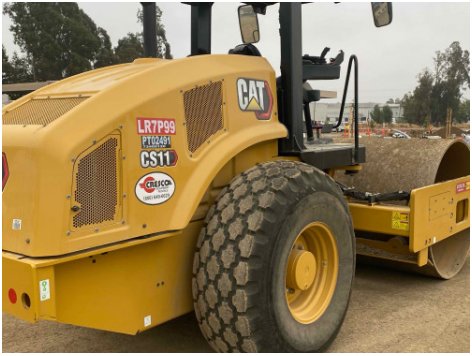
Heavy Mobile Equipment (Excavators, Loaders, etc) **Satisfactory**

No concerns observed.

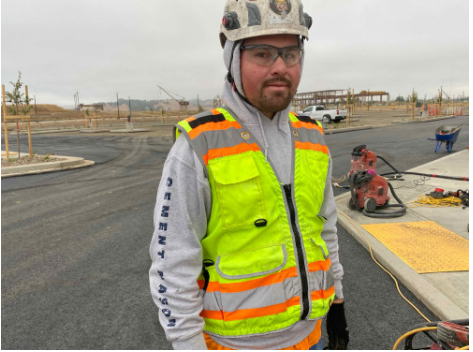
Personal Protective Equipment	Satisfactory
Comment	
Good use of PPE observed during the visit.

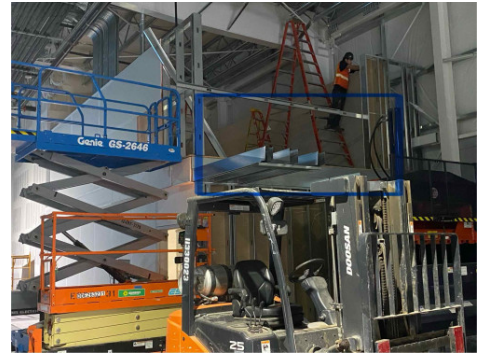
- Temporary guardrail needed on top of a space. Guardrails should consist of a wooden top rail that is 42 inches to 45 inches high and that measures 2 inches x 4 inches or larger. A mid-rail shall be placed halfway between the top rail and the floor. Top rails should support at least 200 lbs of force. Mid-rails should support at least 150 lbs of force. Supports are needed at least every 8 feet to limit rail deflection.

Mid rail and post missing from this location. Top rail must be at 42 inches and the mid rail must be at approximately 21 inches. There should be a support in place every 8 feet at least to prevent deflection of the rails.

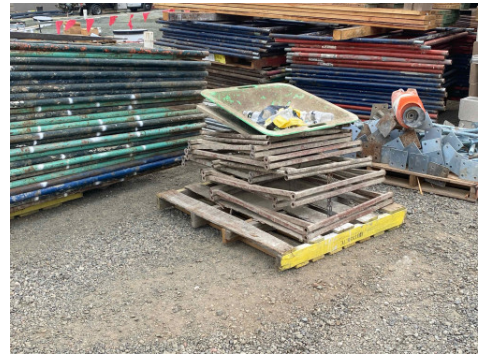
Scaffold observed, organized, and staged neatly.

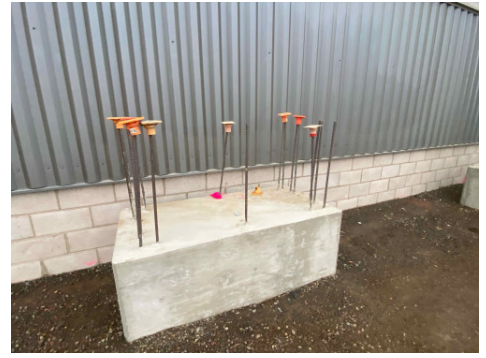
- Rebar poses an impalement hazard.

Note: Cal Osha mentions the following: "Protection from Reinforcing Steel and Other Similar Projections. (1) Employees working at grade or at the same surface as exposed protruding reinforcing steel or other similar projections, shall be protected against the hazard of impalement by guarding all exposed ends that extend up to 6 feet above grade or other work surface, with protective covers, or troughs.

Much of the site has good protection in place. However, a few areas were noted as needing attention.

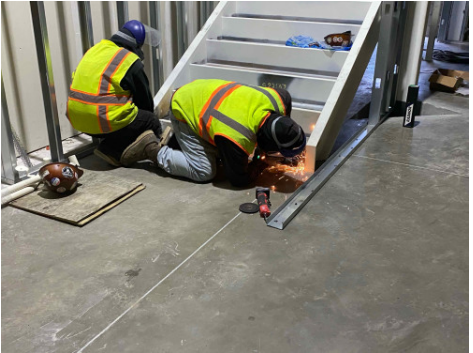
- Worker creating sparks without fire extinguisher or hot work permit in place. Hot work permits help identify hazards and how to mitigate them. Mitigation measure should be in place be for hot work begins. Corrected on site.

Hot Work		Unsatisfactory
Comment		
<p>Worker creating sparks without a fire extinguisher in the area. Worker indicated a hot work permit had not yet been filled out, but that his supervisor was following on getting one. Insure subcontractors put fire control safety measures in place before beginning work.</p>
