# SAFETY INSPECTION REPORT

**PROJECT:**  
Fountaingrove Apartments

**INSPECTION TYPE:**  
General Construction

**INSPECTOR :** JOSHUA JOHNSON  
**DATE :** MAY 28, 2024  
**CITY :** SANTA ROSA  
**STATE :** CA

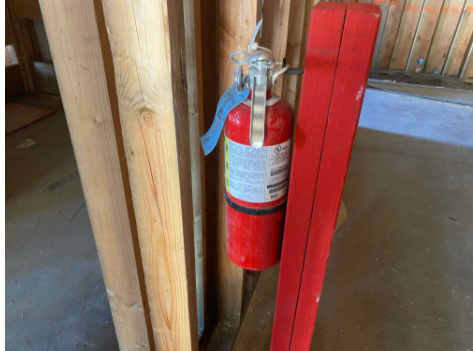
<b>Fire Extinguisher(s)</b>	<b>Satisfactory</b>
-----------------------------	---------------------

<b>Comment</b>	
Good job having plenty of these on the site.

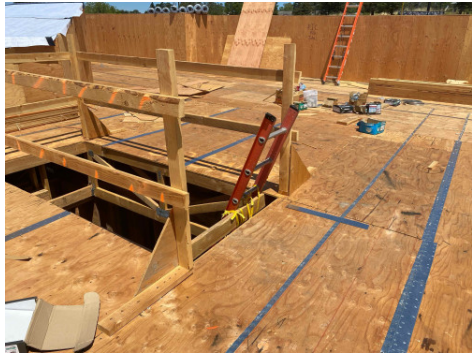
<b>Ladders</b>	<b>Unsatisfactory</b>
----------------	-----------------------

- Ladder leading to the roof of building D needs an offset wall or a gate so that workers cannot fall down the opening where the ladder is located.

Comment	
<p>This ladder accessing the roof of building D needs either a gate or an offset wall to prevent workers from being able to fall down the opening. Please see additional photo for an example of how a offset wall can be used.</p>

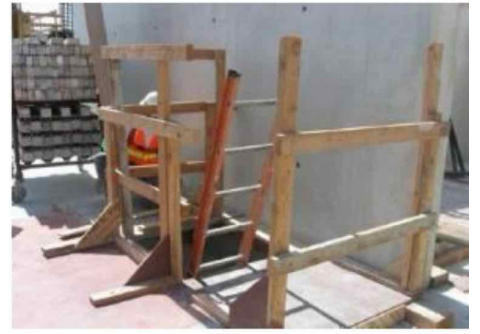
Example of offset wall used for a ladder opening.

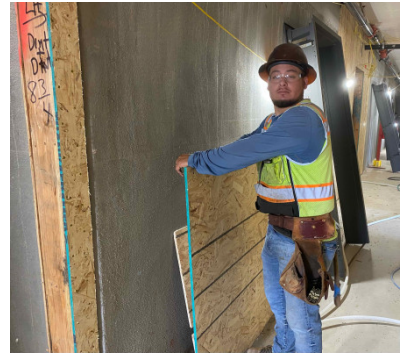
**Personal Protective Equipment**

Good PPE usage observed at several locations on the site.

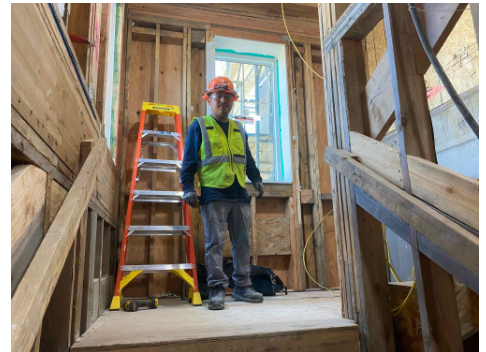
Another example of good PPE usage.

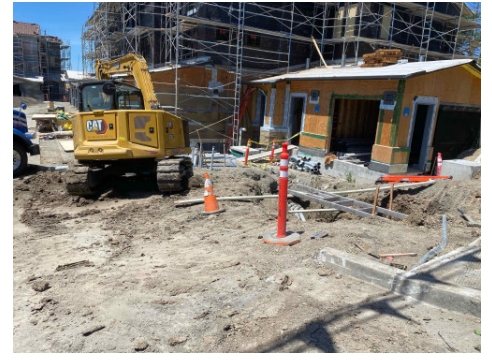
**Trenching & Excavation**

SJ Cimino Electric assured us that this trench would be left in safe condition at the end of the day. Reminders were shared regarding safe trench work. Also, it was indicated that a delineation line would be in place for the trench at the end of the day.

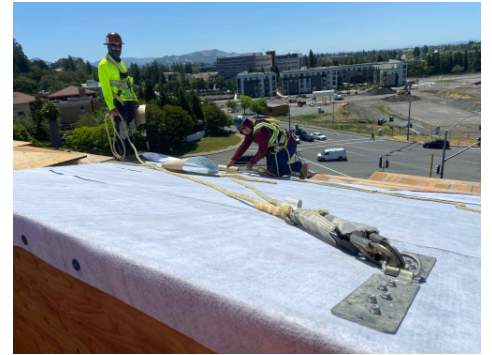
**Fall Protection**

- 2 roofers were connected to one anchor point. These anchor points are typically only rated for one worker. A reminder was given on site and this was corrected.

2 roofers connected to one anchor point. A reminder was given on site. Please see the next photo showing correction.

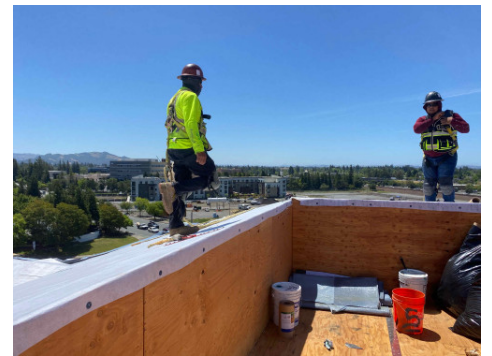
Corrected fall protection use.

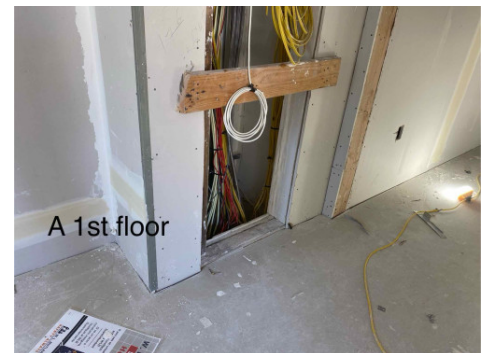
**Guardrails**

- A mid-rail was missing at a chase in building a on the first floor. Note: The site contact is following with caring for this.

Mid rail missing from the chase in building a floor one. Site contact was made aware of this is following.

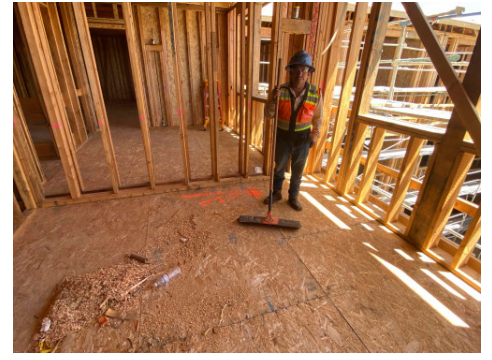
<b>Housekeeping</b>	<b>Satisfactory</b>
---------------------	---------------------

Active housekeeping activities were observed during the visit. Good job!

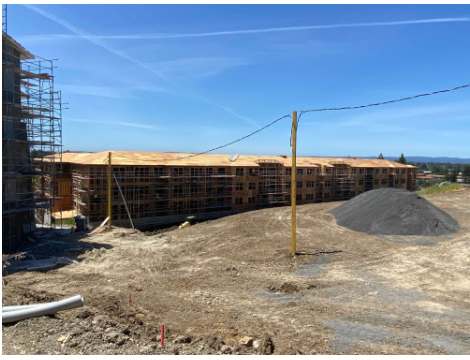
<b>Other Items (that were observed)</b>	<b>Satisfactory</b>
---	---------------------

For the amount of activity on the site, the site is clean and organized. Good job!
