SAFETY INSPECTION REPORT

PROJECT:
Fountaingrove Apartments

INSPECTION TYPE:
General Construction

INSPECTOR : JOSHUA JOHNSON
DATE : JULY 09, 2024
CITY : SANTA ROSA
STATE : CA

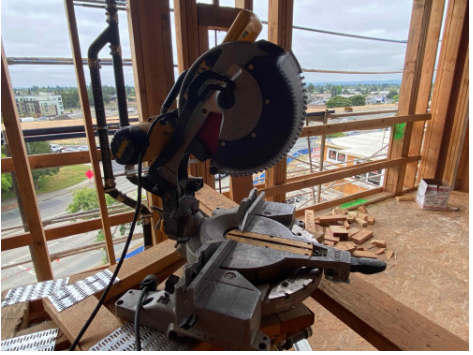
Power Tools		Satisfactory
Comment		
No concerns observed. Guards in place.

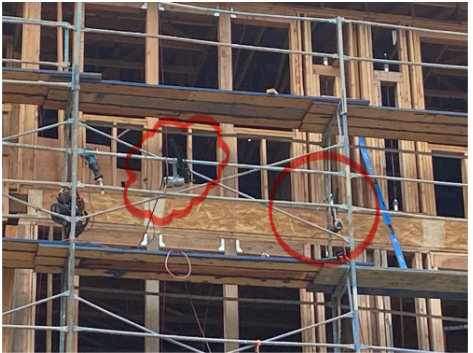
Pneumatic Nailers		Satisfactory
Comment		
No concerns observed. Good job disconnecting them from a power source while left unattended.

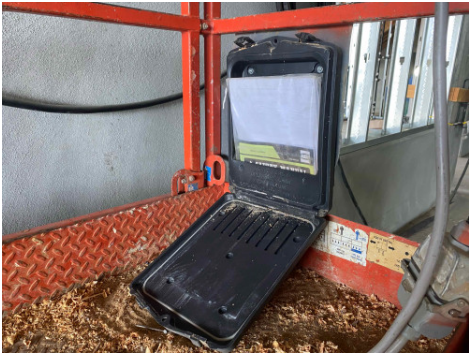
Good job having manuals with scissor lifts.

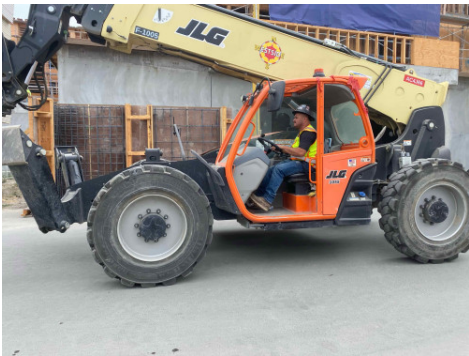
No concerns observed.

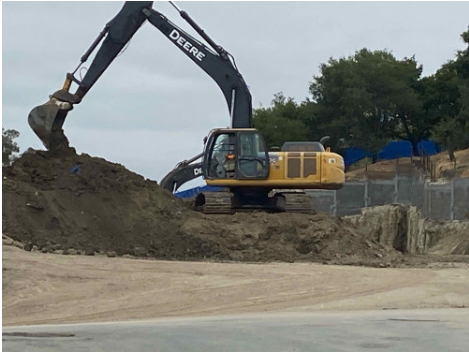
Save use observed.

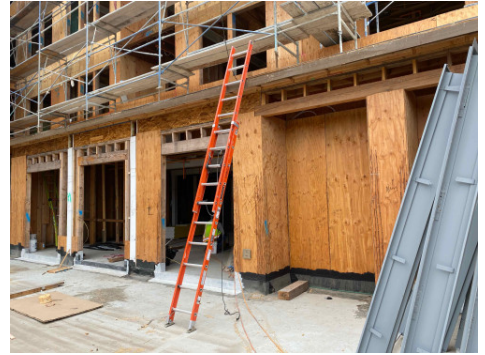
Ciarra ladder not secured or extended 3 feet past level being accessed. On site contact following.

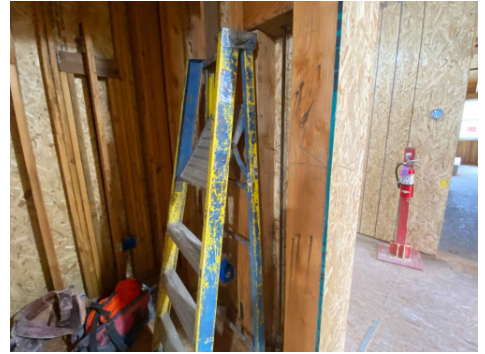
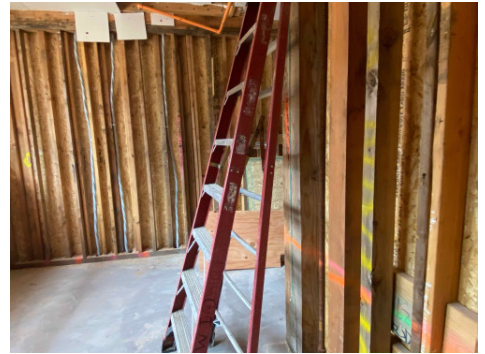
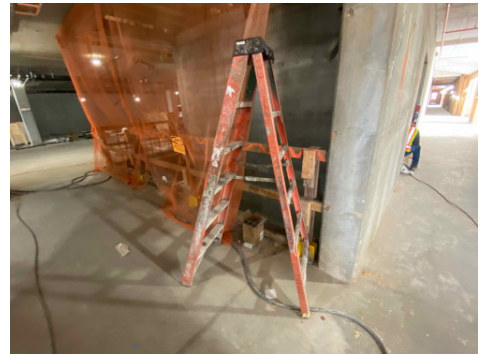
- Ladders missing legible safety and proper use labels were observed throughout the site. Note: A designated competent person can inspect the ladder and attach new stickers after they do an inspection to ensure the ladder is still in good condition and safe for use. Then employees can be made aware the ladder is safe to use.
- A Ciarra extension ladder used for access was setup incorrectly. Site contact following. Note: Extension ladders used for access must extend 3 feet past the level being accessed, have a 4:1 ratio and be secured.

Various ladders around site are missing legible safety labels. See summary for more details.

Another example of labels.

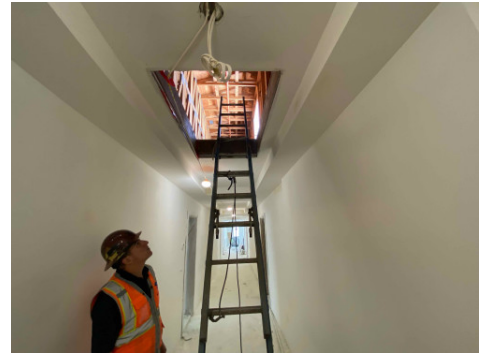
Ladder missing gate or off-set wall. This is a fall hazard. On site contact following.

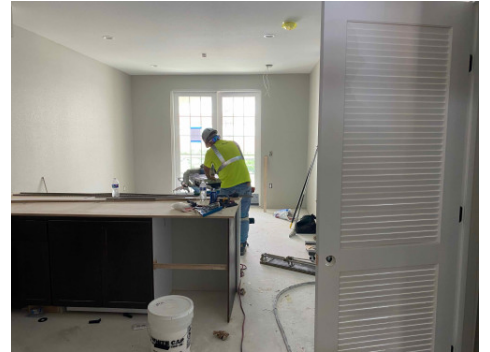
- Tile installers not wearing PPE while cutting tile. Reminder given on site.

Tile installer cutting tile without safety glasses or face protection. Reminder given on site.

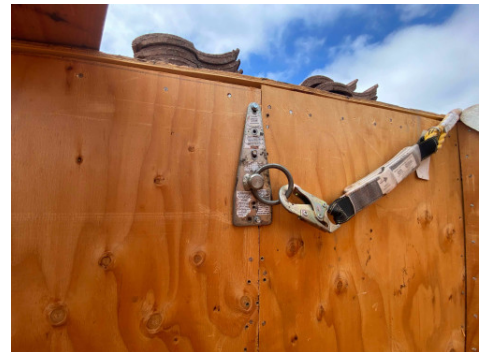
- Temporary anchor for roofers missing screws. Roofing contractor should ensure anchors are installed per the manufacturers guidelines.

Fall protection anchor for roofing contractor not installed correctly. See additional photo of installation instructions.

Installation instructions. Note: proper installation is vital for the fall arrest system to function properly. A compromised anchor, compromises the whole system.

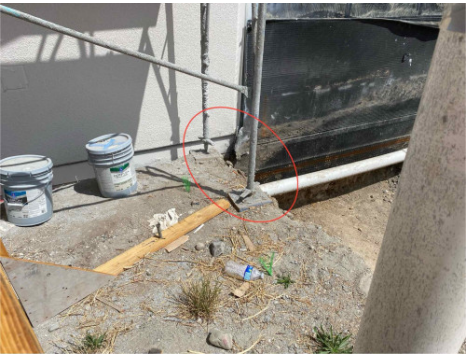
- Scaffolding erected on the edge of a trench. If the trench wall gives out the whole scaffold could fall. Consider taking down the scaffold or changing the way it is supported.
- Guardrails missing for bakers scaffolding being used in a stairway. If workers use the scaffolding without

Supported Scaffolding	Unsatisfactory
Comment	
<p>Scaffolding directly next to a trench. NOTE: if the trench wall gives way this whole scaffold could potentially become compromised and fall. On-site contact made aware and is following.</p>

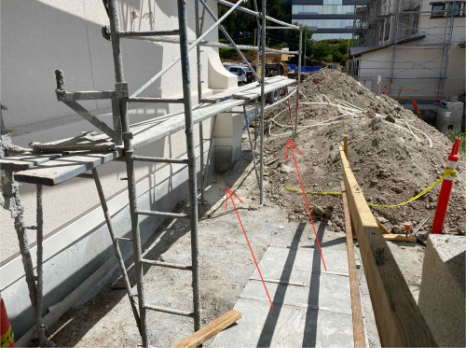
- Scaffold bays missing cross-braces. Ensure cross braces are re-installed per the manufacturers guidelines and structural integrity is maintained.

<p>Cross braces missing at B building. This compromises the structure of the scaffold and is not in line with manufactures instructions. Ensure cross braces are reinstalled.</p>

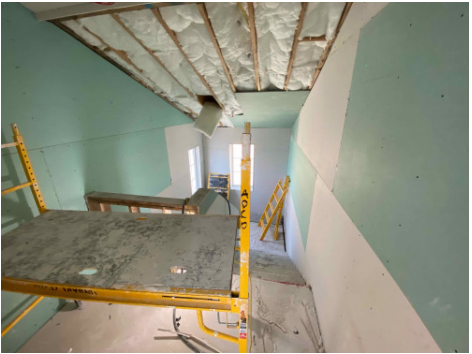
guardrails they will be exposed to a fall greater than 7.5 feet. The on site contact is following. Ensure proper fall protection is being used.

<p>Baker scaffold being used in a stairwell to install drywall. There is no indication of guard rails on site. Given the possible fall distances in the stairwell, we would expect guard rails to be used. Please note the additional photo showing what this type of rail looks like.</p>

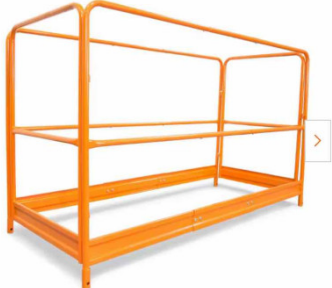
<p>Note the style of rail, that can be used with this Bakers scaffold. Per the manufacturer, the rail should be used when the standing height is 6 feet or above. It should also be used to mitigate a fall of 7 1/2 feet or greater.</p>

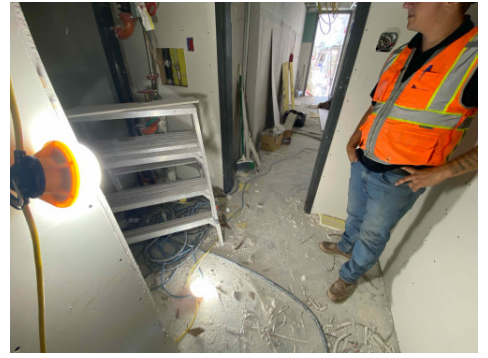
- A sizable amount of debris, scrap lumber and drywall materials are partially blocking stairways, hallways and D-528. It is recommended these items be removed. This could pose a significant trip and fall hazard.

C 1st floor housekeeping is needed. On site contact following.

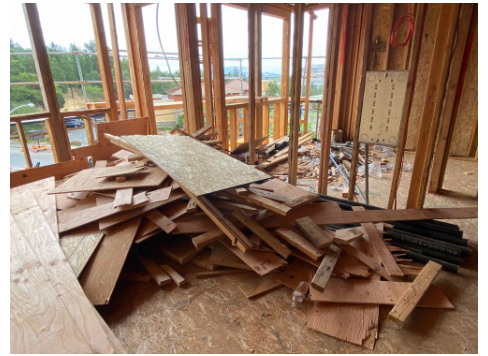
Housekeeping needed at D-528. On-site contact is following.

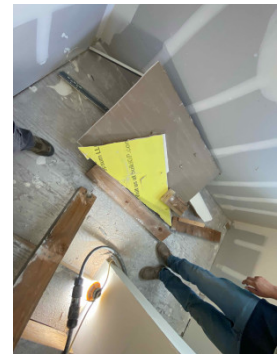
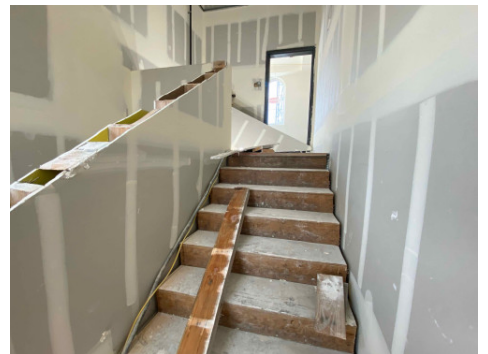
- Drywall demolition debris was left in a stairway creating a trip and fall hazard. Sub-contractor should ensure unsafe conditions are not left for other trades. Consider using the "Clean as you go" method for demolition activities.

Drywall materials left creating a trip hazard in the B 3rd floor stairwell. On-site contact is following. See additional photo.

Additional photo of stairwell.

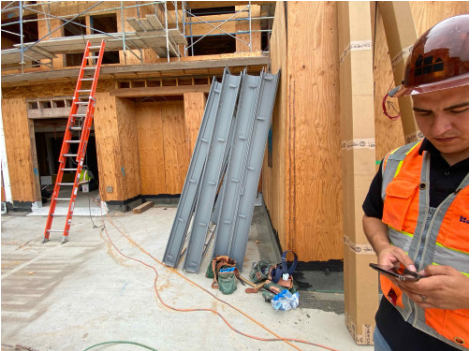
- Door frames are leaned up against the wall at various locations. They are not secured. This is a falling object hazard. Consider securing them or laying them flat.

Comment	
<p>Metal door jams continue to be stored upright around the site. This a falling object hazard. Door jam should be laid down or secured to mitigate this.</p>
