SAFETY INSPECTION REPORT

CONDUCTED FOR:
Woodmont Properties

PROJECT:
Randolph

INSPECTION TYPE:
General Construction

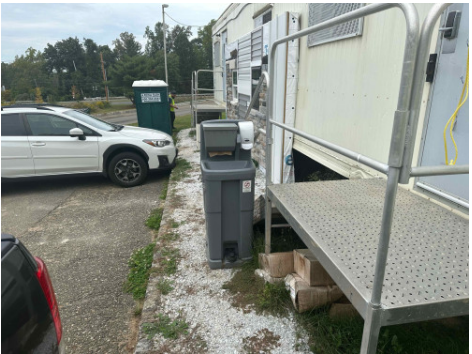
One hand washing facility is now on site

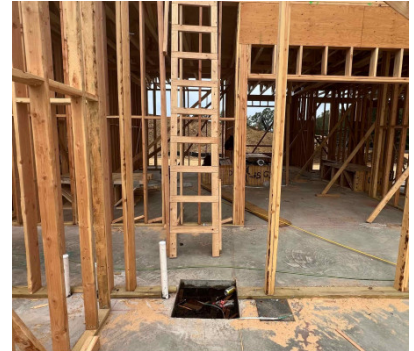
ME WOOD - There needs to be an offset at the 2nd story ladder access opening. At the base level, there is a hole opening near the footing of the ladder. That needs to be secured or the ladder moved.

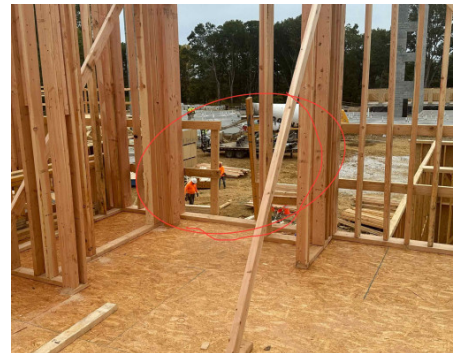
Where the offset noted above is needed

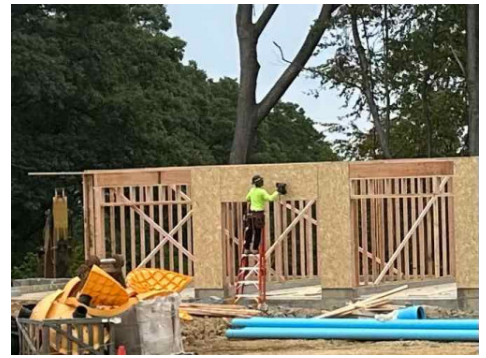
At the garages, an employee was working off a folded step ladder. Ladders must be opened and used as intended.

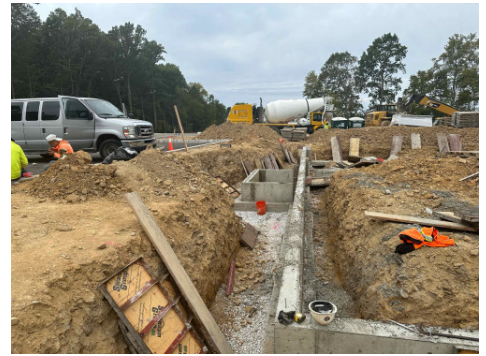
D&P - Workers are using form boards as ladders to get in and out of trenches. In addition, they are jumping from walls to ground. Both are not allowed. Ladders need to be used, and within 25' of workers in the trenches. If ramp crossings are used, they need to adequately support the weight, be at least 20" wide and if higher than 6' have guardrails

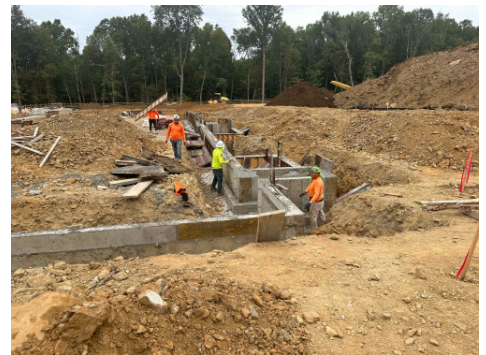
A couple D&P workers were not wearing hard hats or eye protection

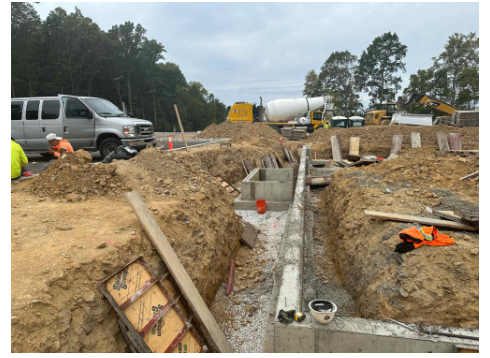
D&P Construction is currently working in excavations/footings. Note that there are areas where there are excavation walls deeper than 5' and they are not sloped back at a minimum of 1:1(45 degrees). This is a hazard that must be corrected.

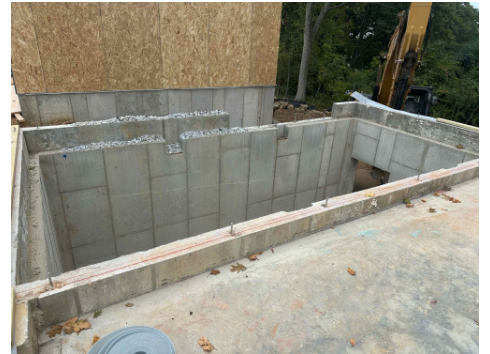
At the backside of the garages (south east side) there is a fall hazard of more than 6' where there is no framed wall. There is also a fall hazard overlooking the pump room. These areas need to be protected with guardrails.

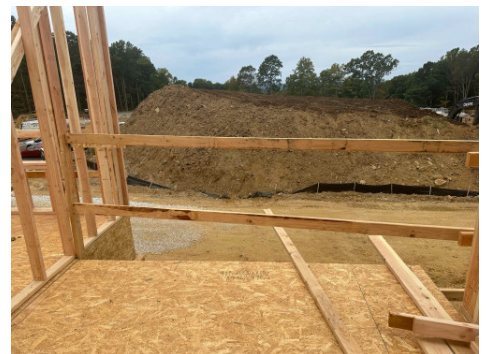
ME Wood - A reminder that when wood railing is used, uprights need to be in place every eight feet. While most railing is good, there are some railings that do not have uprights every eight feet. This photo shows an example and the railing is loose.

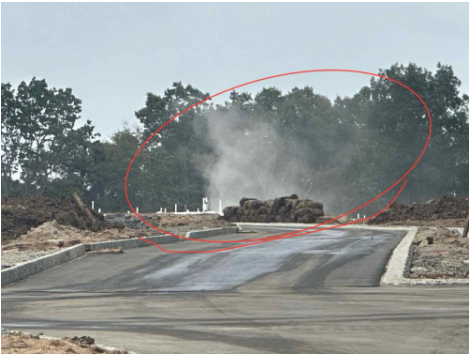
Mobile Scaffolding	N/A
Suspended Scaffolding	N/A
Confined Spaces	N/A
Impalement Hazards	Unsatisfactory
Comment	
D&P Construction has exposed impalement hazards that need to be protected along the south side building foundation	-
Traffic Control	N/A
Roofing Operations	N/A
Housekeeping	Satisfactory
Demolition	N/A
Silica Control	Unsatisfactory
Comment	
Workers were cutting concrete without an engineering control such as integrated water. This created a huge cloud of dust containing silica. They need a site specific silica exposure control plan and follow it.
