SAFETY INSPECTION REPORT

CONDUCTED FOR:
Woodmont Properties

PROJECT:
Randolph

INSPECTION TYPE:
General Construction

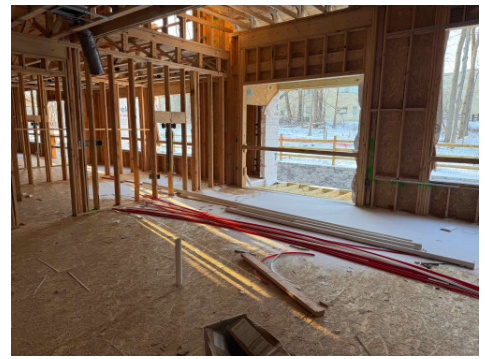
While railing is in place in most areas, there are areas with railing missing. This is in all framed buildings. Sub contractors just cannot remove railing and not replace it. This should be inspected daily by Woodmont on site. Example Pic #1 of proper guard railing @ loading area. Pic #2 of missing railing @ loading area.

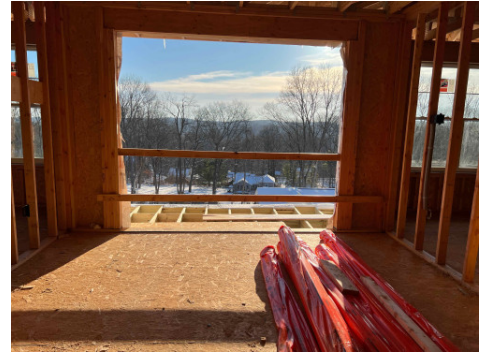
- While railing is in place in most areas, there are areas with railing missing. This is in all framed buildings. Sub contractors just cannot remove railing and not replace it. This should be inspected daily by Woodmont on site.

Guardrails	Unsatisfactory
-------------------	-----------------------

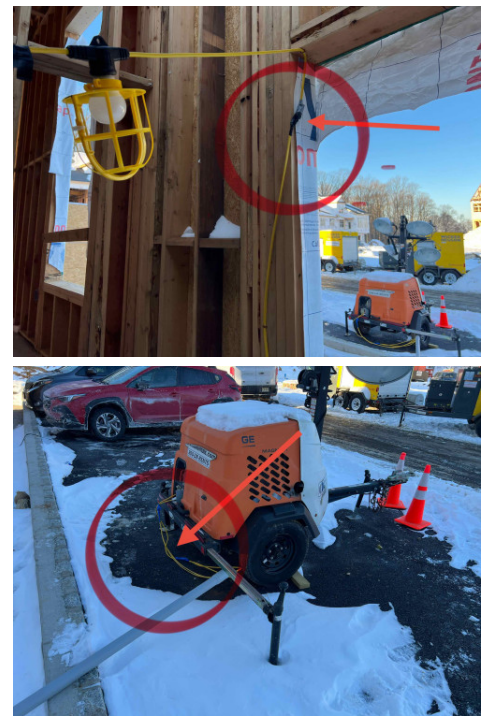
Electrical Safety	Unsatisfactory
--------------------------	-----------------------

While conduit is now being used to protect the electrical cables for the temporary lighting there is still a hazard at the splicing locations where the connections have just been taped and are either lying on the ground or exposed to moisture. This needs to be corrected.
