# PROJECT INSPECTION

<b>Company</b>	Helio	<b>Type of Inspection:</b>	SCC USE ONLY: General Contractor Review
<b>Project</b>	Canfield	<b>Date of Inspection</b>	November 21, 2022
<b>Inspector Name</b>	Jeremy Chavez	<b>Time of Inspection</b>	11:50 AM

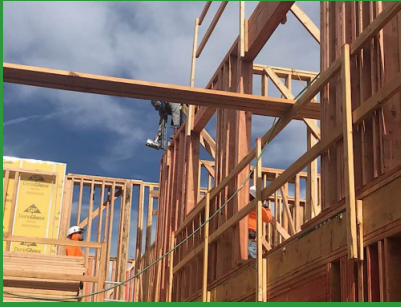
An employee is working above his trigger height without the use of personal fall protection while he installs guardrails.

Employees must use personal fall when working above their trigger height, even if the duration is relatively brief, such as when installing guardrails

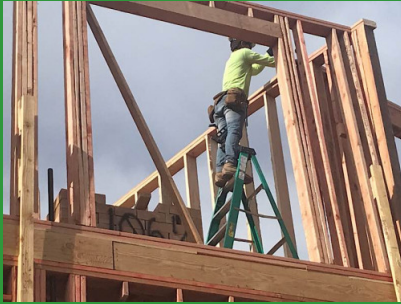
Employee is standing on the 2nd to top step of an A-Frame ladder while he is next to a wall opening.

Please ensure employees use the approved steps. When working next to wall openings, additional protection may be required, such as guardrails.

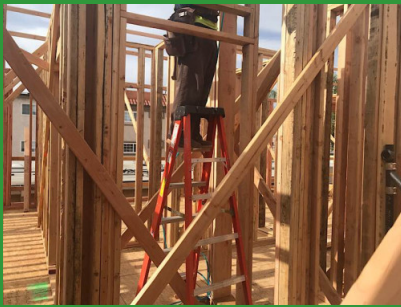
Employee is standing on the 2nd to top step of an A-Frame ladder, which is prohibited.

Please ensure employees use the approved steps.

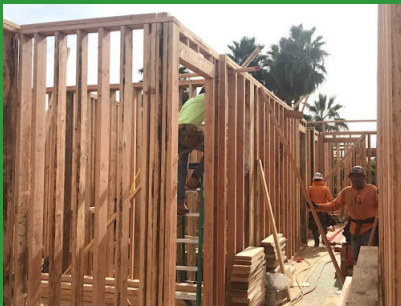
Employee was observed standing on the 2nd to top step of an A-Frame ladder, which is prohibited.

Please ensure employees use the approved steps.

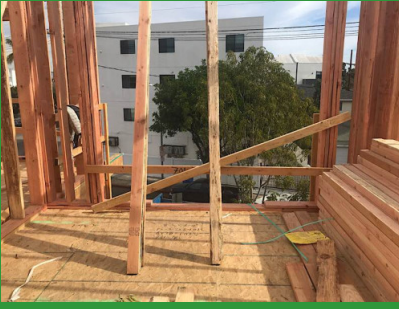
There were a few areas where guardrails were missing.

Please ensure guardrails are installed where required.

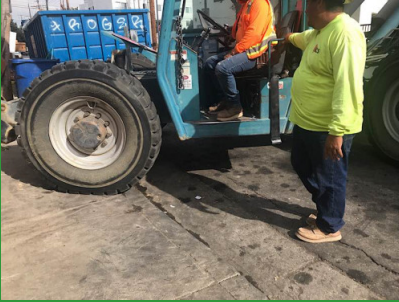
An employee is operating a reach lift while not wearing his seatbelt.

Please ensure employees wear their seatbelt while operating equipment.
