PROJECT INSPECTION

Company	Helio	Type of Inspection:	SCC USE ONLY: General Contractor Review
Project	Canfield	Date of Inspection	December 11, 2023
Inspector Name	Jeremy Chavez	Time of Inspection	01:45 PM

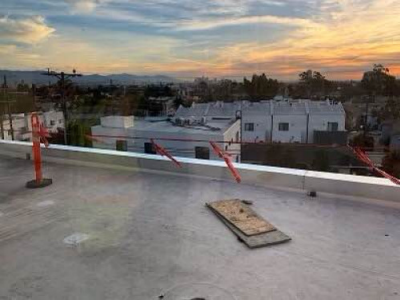
<p>Danger tape is in use as a warning line on the roof, which is not permitted. Please ensure a warning line with the approved materials is installed. The details were discussed with Chris Sandberg.</p>

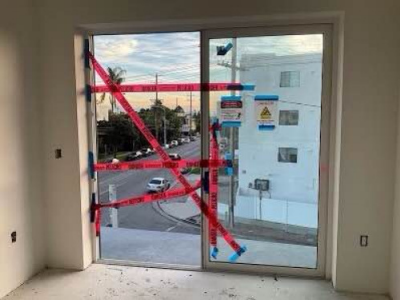
<p>Danger tape and signage have been installed, which is not a form of fall protection. Chris Sandberg commented that the main door to the unit will be closed. Personal fall protection is planned to be used during installation of the sliding glass door.</p>

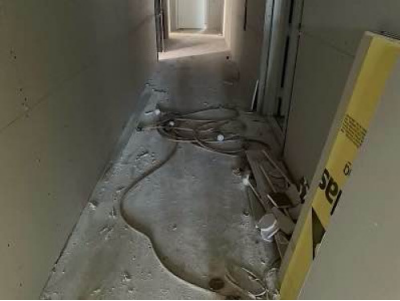
<p>There are a couple of areas where cords are in a walkway. Please ensure housekeeping gives attention to these areas.</p>
