# PROJECT INSPECTION

| <b>Company</b> | Helio | <b>Type of Inspection:</b> | SCC USE ONLY: General Contractor<br>Review |
| <b>Project</b> | Venue | <b>Date of Inspection</b> | February 07, 2022 |

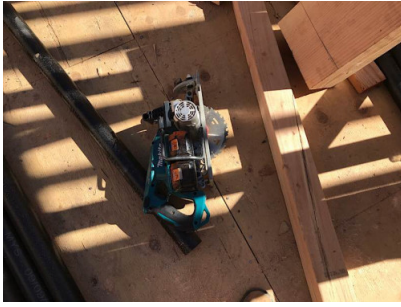
The guard of this skill saw was removed due to damage after it was dropped.

It was observed in use, however, once the missing guard was identified it was removed from the project.

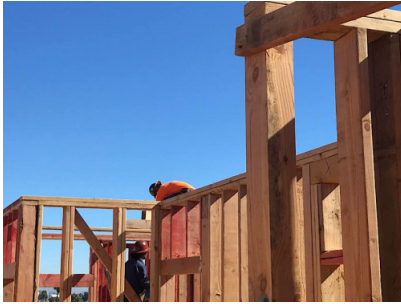
Employee is working at an unprotected edge while not using personal fall protection. This exposes him to a significant fall hazard.

Employee got down and went to obtain a harness, lanyard, and anchor point.

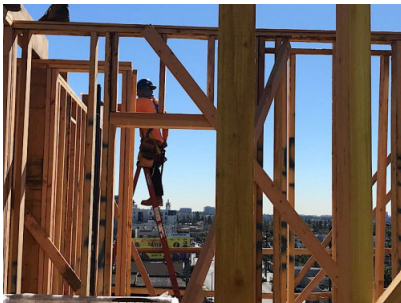
Employee is working on a ladder while adjacent to an edge. The employee is above the protection provided by the guardrails installed, which exposes him to a significant fall hazard.

Employee moved the ladder to an area that eliminated the fall exposure.
