# PROJECT INSPECTION

<b>Company</b>	Helio	<b>Type of Inspection:</b>	SCC USE ONLY: General Contractor Review
<b>Project</b>	Venue	<b>Date of Inspection</b>	April 18, 2022
<b>Inspector Name</b>	Jeremy Chavez	<b>Time of Inspection</b>	12:00 PM

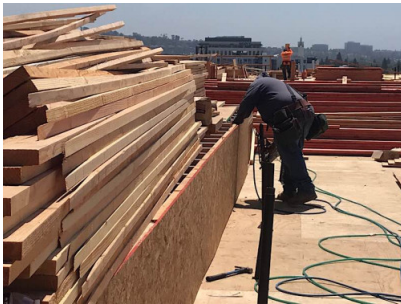
Employee is using a nail gun while not wearing safety glasses. Additionally, the employee must use a hard hat while on site.

The employee complied to don the required safety glasses and hard hat.

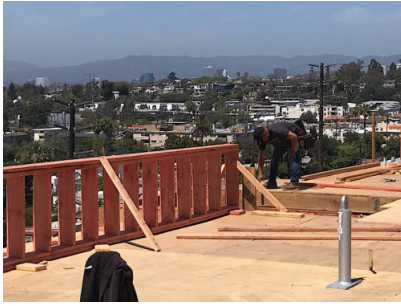
Employee is standing within 6' of an unprotected edge which exposes him to a significant fall hazard.

Employees must use personal fall protection when working above their trigger height. During framing operations, employees are allowed a 6' distance exception. Outside of framing activities, even though an employee is a framer, there is no safe distance from an unprotected edge. Distance is not a means of fall protection in such cases and a physical barrier must be provided.

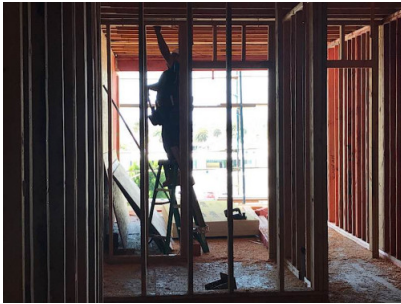
Employee is standing on the 2nd to top step of an A-Frame ladder, which is prohibited.

Please ensure employees use only the approved steps. This may require the use of a taller ladder.

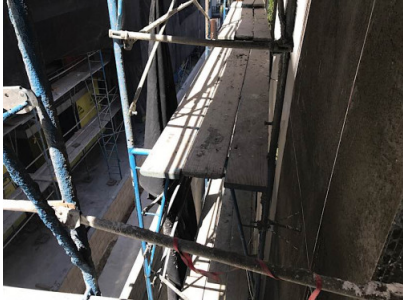
A guardrail is missing at this section of scaffolding.

By reinstalling the missing guardrail the fall hazard will be protected.
