PROJECT INSPECTION

Company	Helio	Type of Inspection:	SCC USE ONLY: General Contractor Review
Project	Venue	Date of Inspection	April 27, 2022
Inspector Name	Jeremy Chavez	Time of Inspection	09:15 AM

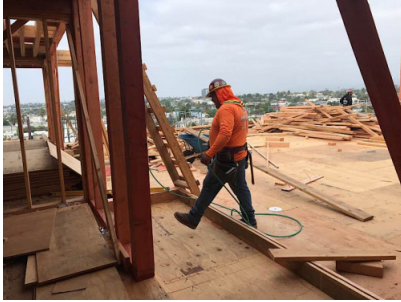
Another Proffer employee is using a nail gun while not wearing safety glasses.

Proffer employees must wear the required PPE, including safety glasses.

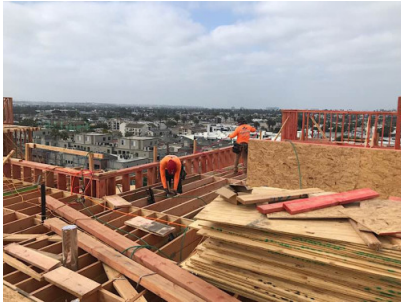
Proffer employees are exposed to a fall hazard above their trigger height while a means of fall protection is not in use.

A practical method to provide a means of fall protection is to install guardrails. Railing installed must be 42-45" top rail with a mid rail halfway between the top rail and the working platform.
