PROJECT INSPECTION

Company	Helio	Type of Inspection:	SCC USE ONLY: General Contractor Review
Project	Venue	Date of Inspection	April 04, 2022
Inspector Name	Jeremy Chavez	Time of Inspection	11:00 AM

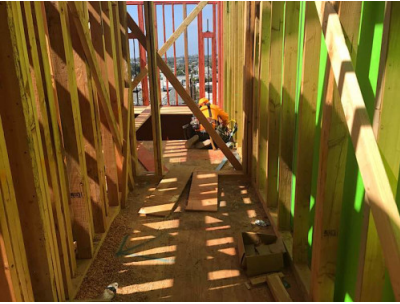
Stairs are in the process of being installed to the top floor. This has been an ongoing process.	Two sets of stairs must be completed to the top floor.

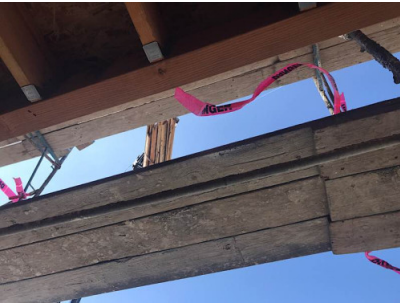
Proffer is flying a load while a tagline is not equipped.	Taglines must be used to ensure a load does not swing, twist, or turn when the load is landed.
