PROJECT INSPECTION

Company	Helio	Type of Inspection:	SCC USE ONLY: General Contractor Review
Project	Venue	Date of Inspection	August 01, 2022
Inspector Name	Jeremy Chavez	Time of Inspection	11:00 AM

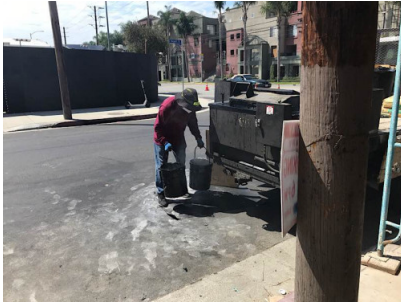
Employee is handling hot tar while not wearing safety glasses and a face shield.

The employee reported he would obtain the required PPE.

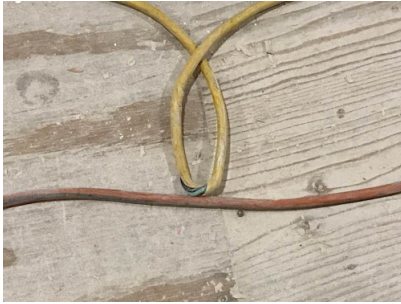
An extension cord has damaged insulation.

The cord was immediately discarded. Please ensure extension cords are inspected daily. Any damaged extension cords must be identified prior to use and discarded.

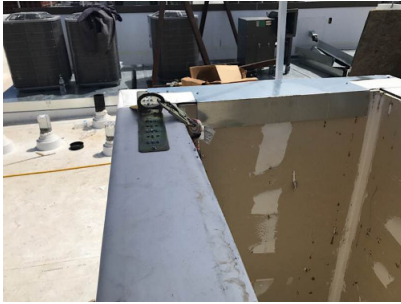
LDI has a lanyard installed to an anchor point that would be side loaded in the event of a fall, which exceeds the intended angle of use.

Please ensure the manufacturer's guidelines are followed for installation, which typically limits the angle to no more than 30 degrees. Also, a written rescue plan must be provided.

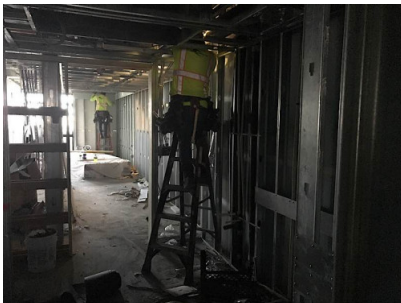
Employee is straddling an A-Frame ladder, which is prohibited.

The employee complied to use the approved steps of the ladder.

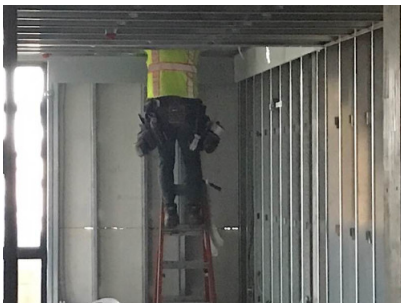
Employee is standing on the 2nd to top step of an A-Frame ladder, which is prohibited.

Employee complied to use the approved steps of the ladder.
