PROJECT INSPECTION

Company	Helio	Type of Inspection:	SCC USE ONLY: General Contractor Review
Project	Venue	Date of Inspection	September 07, 2022
Inspector Name	Jeremy Chavez	Time of Inspection	09:00 AM

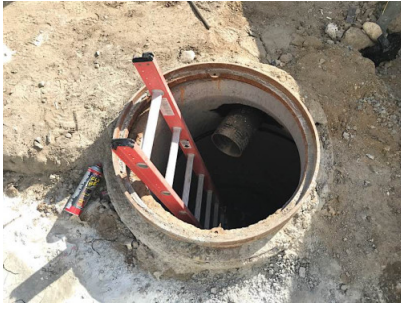
The pictured confined space was left unattended while the cover was removed. Additionally the confined space has not been identified as a confined space.

Please ensure confined spaces that present fall hazards are covered, or otherwise protected. Additionally, warning signs must be posted at the entrance of confined spaces. As a general reminder, only trained and authorized entrants, attendants, and supervisors are permitted to work with confined spaces when the necessary PPE, plan, and documentation have been provided and followed.

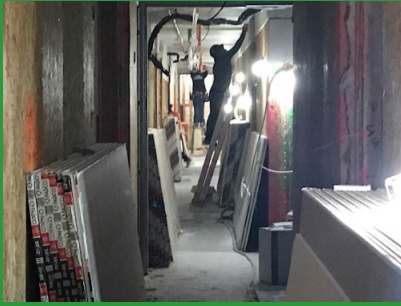
An employee is using an A-Frame ladder in a closed position, which is prohibited.

The employee complied to use the ladder in an open, locked, and level position.

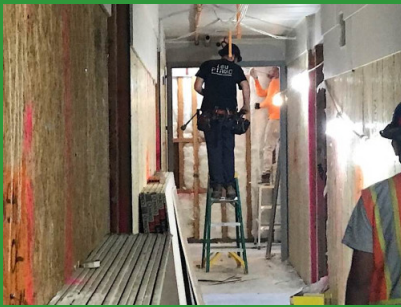
An employee is standing on the 2nd to top step of an A-Frame ladder, which is not allowed.

The employee complied to obtain a taller ladder.

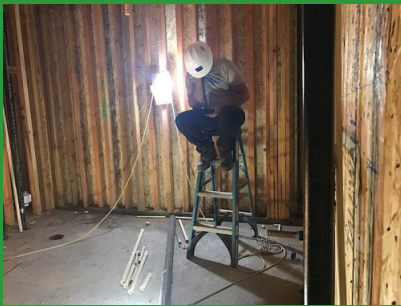
An employee is sitting on the top cap of an A-Frame ladder, which is prohibited.

The employee complied to use the approved steps of the ladder.

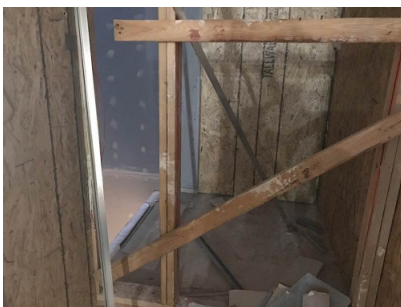
There were a few areas where railing did not meet the required standard.

Please ensure guardrails are installed at 42-45" in height for the top rail. The mid rail must be halfway between the top rail and the working platform. As a general reminder, vertical posts must not exceed 8' in distance between posts.

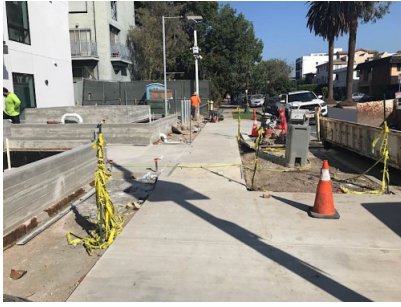
Metal stakes below 6' in height present impalement hazards for both contractors and the public.

Please ensure metal stakes are capped.

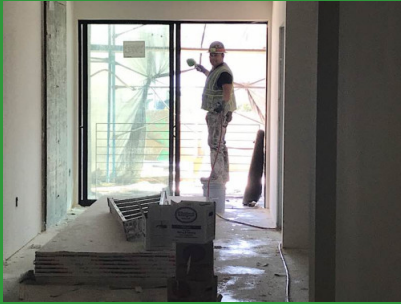
An employee is using a bucket as a means to gain elevation, which is prohibited.

The employee complied to use a ladder.

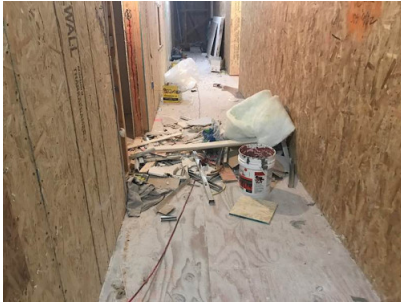
There were a few areas where debris, materials, cords, and hoses were in a walkway and creating tripping hazards.

These areas were discussed with the superintendent. He assigned employees to make corrections.
