**Site Safety General Contractor Review**

**San Joaquin Valley Homes**

**Project:  
Pheasant Court**

**Date:**  
7/13/2022

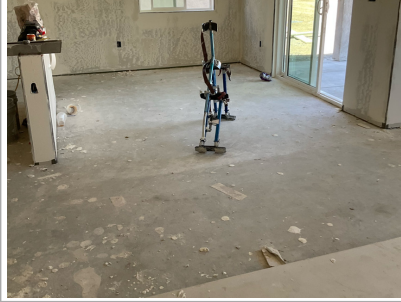
NGC Drywall has stilts on job site. Stilts are prohibited.

<b>Example:</b>	NGC Drywall has stilts on job site. Stilts are prohibited.	<b>Example:</b>	NGC plaster has exposed wires on hopper (Fire hazard)

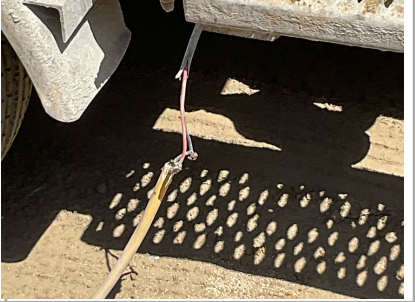
NGC plaster has exposed wires on hopper (Fire hazard)

**NGC drywall has stilts on job site, stilts are prohibited in the state of California. NGC Plaster has a damage power cord with visible exposed wires on the Hopper that can cause an electrical fire, and electrocution due to water being near the unit, Hooper must not have exposed wires and must be fully insulated. Morton & Brown Plumbing missing caution tape on trench, trenches need policing. All other trades were in compliance at the time of my visit. The site is well kept and clean with good housekeeping.**
