SAFETY INSPECTION REPORT

PROJECT:
Bay Shore Hotel

INSPECTION TYPE:
General Construction

INSPECTOR : LINDSEY CRAVEN
DATE : NOVEMBER 20, 2024
CITY : NEWPORT BEACH
STATE : CA

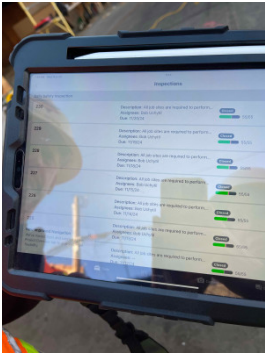
Daily Inspections	Satisfactory
Comment

<p>Daily inspections are being performed</p>

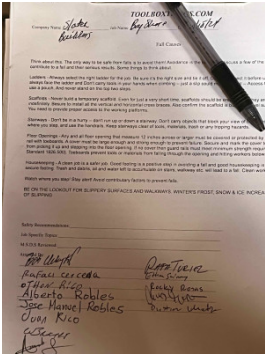
Tailgate Meetings **Satisfactory**

<p>Tailgates are being conducted at least every 10 working days</p>

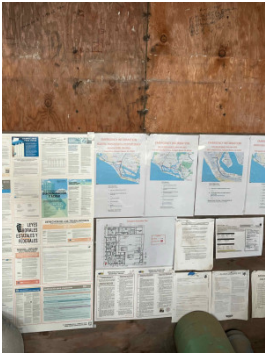
Emergency / Other Postings **Satisfactory**

<p>Emergency posters are on site and directions to nearest medical facility are posted.</p>

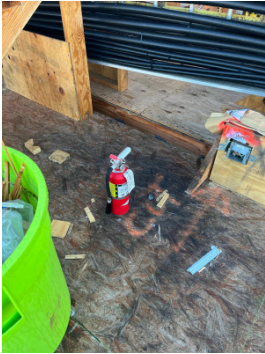
<p>Fire Extinguisher(s) Satisfactory</p>	
<p style="text-align: center;">Comment</p>

<p>Located throughout site.</p>

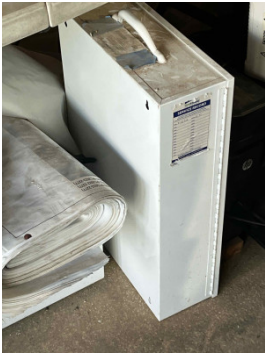
<p>First Aid Kit(s) Satisfactory</p>	
<p style="text-align: center;">Comment</p>

<p>Located in job office</p>

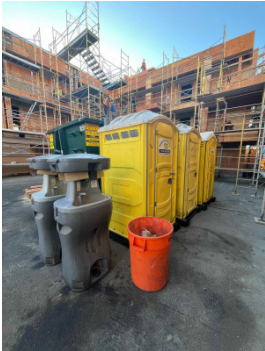
<p>Restrooms</p>	<p>Satisfactory</p>
-------------------------	----------------------------

<p>Plenty of toilets are located on site and are being kept clean and in good working order.</p>

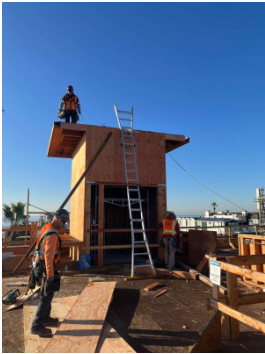
Ladders	Satisfactory
----------------	---------------------

<p>Advanced Framing- Extension ladder is tied off and extends past landing.</p>

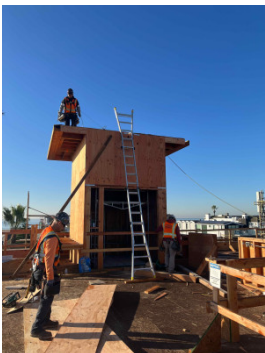
<p>Fall Protection</p>	<p>Satisfactory</p>
-------------------------------	----------------------------

<p>Comment</p>	
<p>Advanced Framing - tied off on roof.</p>

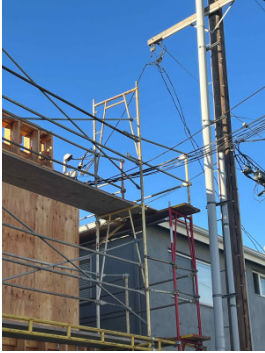
Supported Scaffolding	Unsatisfactory
------------------------------	-----------------------

Comment	
<p>A few safety concerns were noticed with the power lines running through scaffolding along the alley. A couple things to consider: 1.) the exact voltage needs to be determined for all power lines running through scaffolding. 2.) all insulated wiring needs to be inspected daily to ensure the outer sheathing is not damaged. And to ensure all one bolt connectors are properly covered / insulated. 3.) When it comes to the clearance distance of scaffolding, there is no specific standard for lines under 600v. (Voltage still needs to be confirmed) However, it is reasonable to conclude that precautions be taken for scaffold and people not to come in contact with the insulated low voltage lines so as not to damage them. 4.) the scaffold parts are resting on the power lines which could damage the lines and lead to potential shock. 5.) the power lines are running through the scaffolding which creates a tripping and access hazard which is unsafe and not allowed. Because there are so many precautions that need to be considered and applied it is best from the lines to be moved and not ran through the scaffolding. Or, it would be best for the scaffolding to be erected in a manner where it stops and starts so no lines are run through, or resting on, the scaffolding.</p>

Site is clean and organized.	-
Demolition	N/A
Silica Control	N/A
Rigging Operations	N/A
Hot Work	N/A
Electrical Safety	Unsatisfactory
Comment	
See scaffolding.	-
Lockout / Tagout	N/A
Stairways, Ramps, Runways	Satisfactory
Other Items (that were observed)	N/A
