# SAFETY INSPECTION REPORT

Thomas James Homes: NorCal

1893 Vassar Ave. Mountain View

General Construction

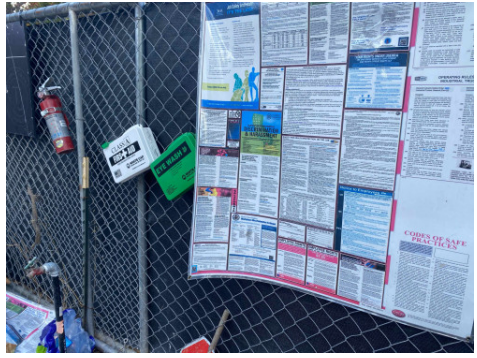
**Labor Law Postings** **Satisfactory**

Good job having these posted.

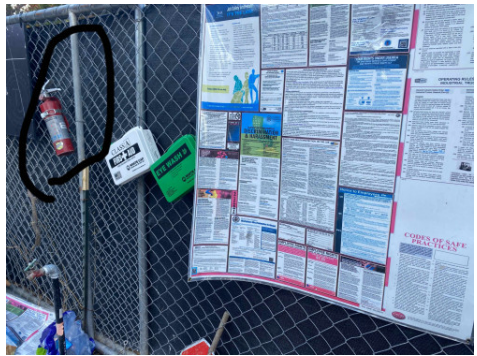
**Fire Extinguisher(s)** **Satisfactory**

Good job having this in place.

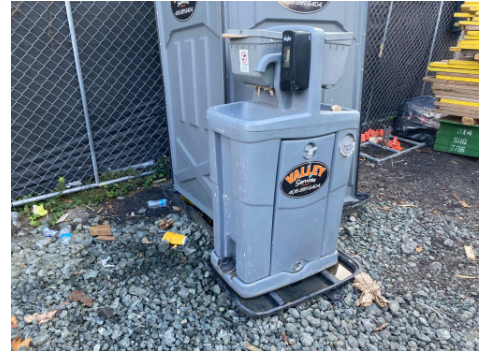
**Hand Washing Stations**

Good job having this in place.

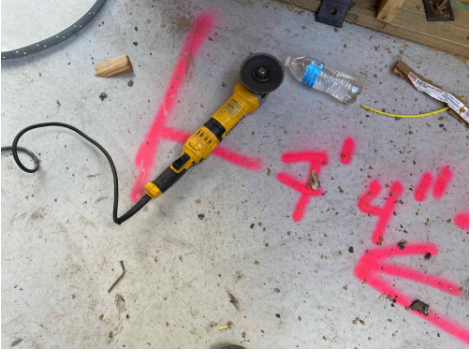
**Power Tools**

- Grinder missing necessary guards. Guards should never be removed, even if it seems needed to perform the work. Removing guards and using the tool is against manufacturers instruction and could result in a cut or amputation.

<p>Grinder observed without a guard in place.</p>

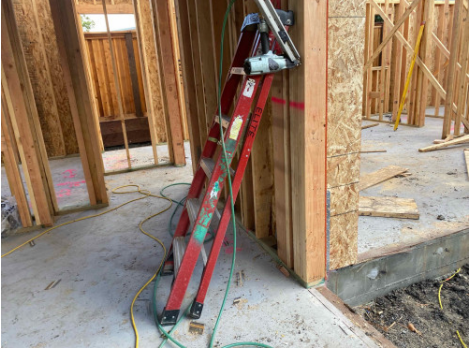
<p><b>Pneumatic Nailers</b></p>	<p><b>Unsatisfactory</b></p>
---------------------------------	------------------------------

- A nail gun was left unattended and plugged into a air compressor. Manufacturer instructions require these be un-plugged from an air source when they are unattended. Cal/Osha indicates the following: "Safety training shall be conducted prior to initial assignment to operate pneumatically-driven nailers or staplers. Refresher training shall be provided to the operator when: The operator has been observed using the pneumatically-driven nailer or stapler in an unsafe manner." This training should be verified.

<p><b>Comment</b></p>	
<p>Nailer left plugged in but unattended. Note: no one was observed using the ladder.</p>

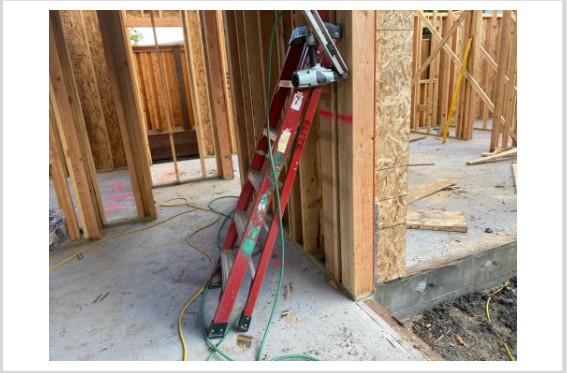
<b>Ladders</b>	<b>Satisfactory</b>
----------------	---------------------

This ladder was not observed being used. However, as a reminder, a frame ladder should not be leaned to work on them.
---

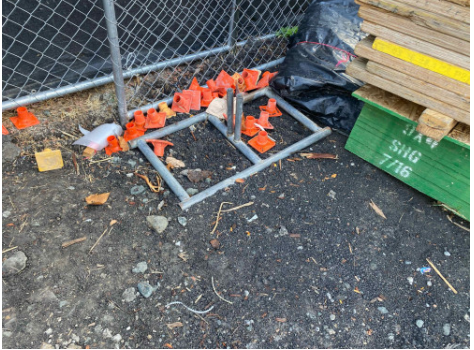
<b>Impalement Hazards</b>	<b>Unsatisfactory</b>
---------------------------	-----------------------

- Fence base and installed supports pose an impalement hazard.

Note: Cal Osha mentions the following: "Protection from Reinforcing Steel and Other Similar Projections. (1) Employees working at grade or at the same surface as exposed protruding reinforcing steel or other similar projections, shall be protected against the hazard of impalement by guarding all exposed ends that extend up to 6 feet above grade or other work surface, with protective covers, or troughs.

<b>Comment</b>	
Fence base is a hazard. Ensure that it is protected and removed from the site.

A photograph showing the base of a chain-link fence where it meets the ground. The ground is covered in dark gravel. There are several orange plastic safety cones placed around the base of the fence. To the right, there is a stack of wooden pallets and a green metal container with the number '716' on it.
Installed support is a hazard. Ensure that it is protected.	  A photograph showing a metal support structure, possibly a rebar or a piece of machinery, protruding from the dark gravel ground. The support is a vertical metal rod with a small white cap or label at the top.

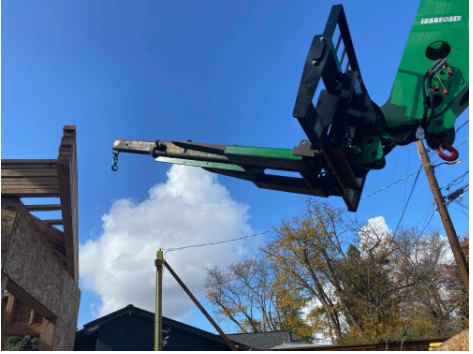
**Rigging Operations** **Satisfactory**

<b>Comment</b>	
As a reminder, subcontractors should ensure that all workers performing rigging have documented rigging training.

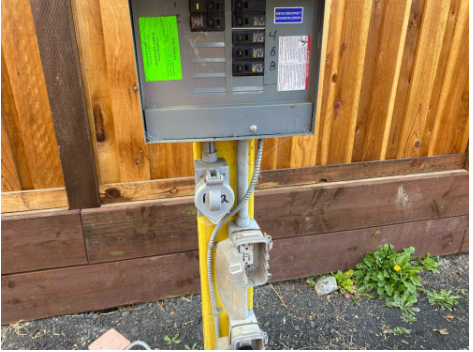
**Electrical Safety** **Satisfactory**

<b>Comment</b>	
Good job having all covers in place.

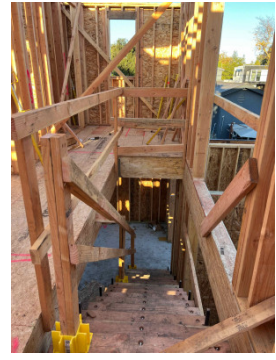
**Stairways, Ramps, Runways** **Satisfactory**

The site contact did an excellent job getting a couple rails repaired on the stairway. Subcontractors should ensure that stairways are left in safe condition.
