# SAFETY INSPECTION REPORT

**CONDUCTED FOR:**  
West Builders, Inc.

**PROJECT:**  
Fullerton HUB

**INSPECTION TYPE:**  
General Construction

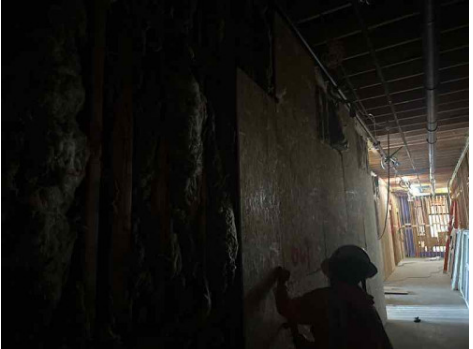
<b>Access / Egress</b>	<b>Unsatisfactory</b>
------------------------	-----------------------

<b>Comment</b>	
<p>It appears Trademark workers have unplugged temp lighting for power tools in use. However, alternate extensions of power should be used. The workers are working in dark conditions without task lighting and turning off all access lighting in the hallway. Please ensure proper extensions of power are in use.</p>

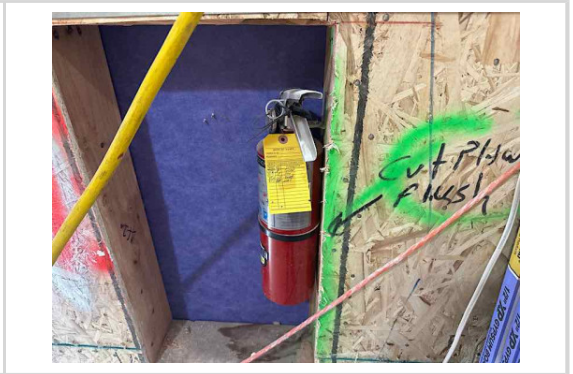
<b>Fire Extinguisher(s)</b>	<b>Satisfactory</b>
-----------------------------	---------------------

Good job keeping fire extinguishers inspected.

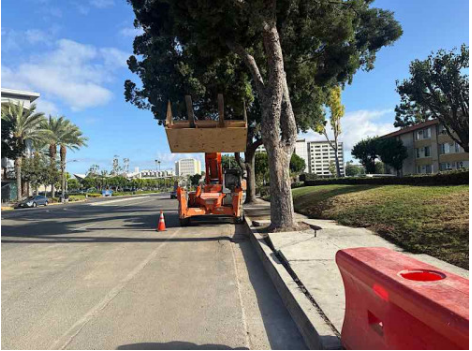
<b>Powered Industrial Trucks</b>	<b>Unsatisfactory</b>
----------------------------------	-----------------------

<b>Comment</b>	
When operating in the public roadway a spotter is required.	 
When parking the lift the forks must rest flush on the ground with the mast at a neutral position.

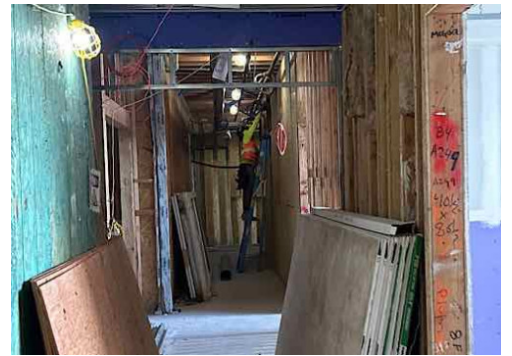
Trademark worker has a leaned A Frame ladder. Please ensure the ladder opened and locked when in use. A LeanSafe ladder may be used in this application.

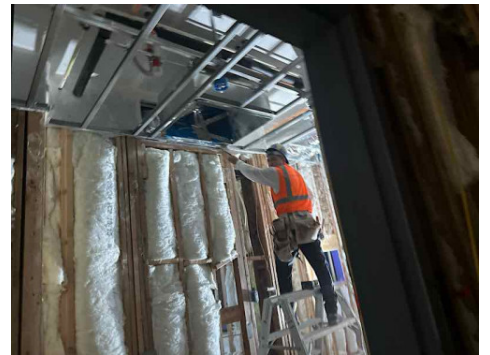
### Personal Protective Equipment

Sharp worker does not have ansi rated safety glasses. Please ensure all workers engaged in cutting activities have proper PPE.

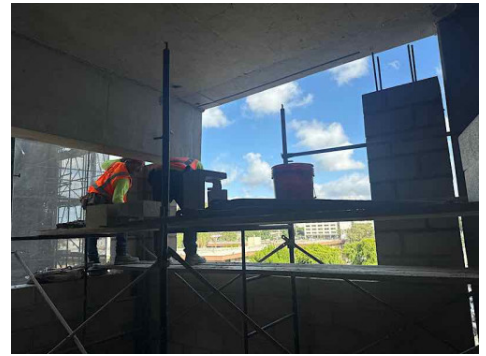
Guy Yocom workers are exposed to fall hazard wiring without guard rails. The work consists of finishing block columns. The guard rails must be in place where workers are exposed and no work is accomplished. The workers complied to erect guard rails immediately.

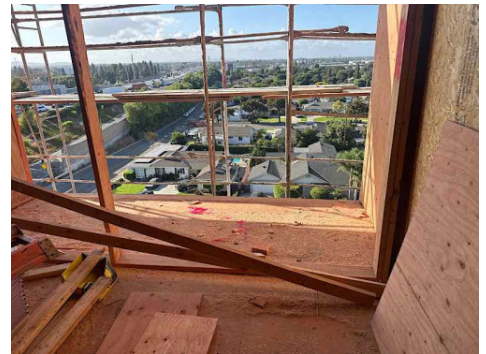
**Guardrails**

Guard rails have been removed. It is important to note the scaffold does not count as a catch platform as it is greater than 24" from the fall hazard and does not have an outside toe board. Please ensure any contractors who remove guard rails must return them.

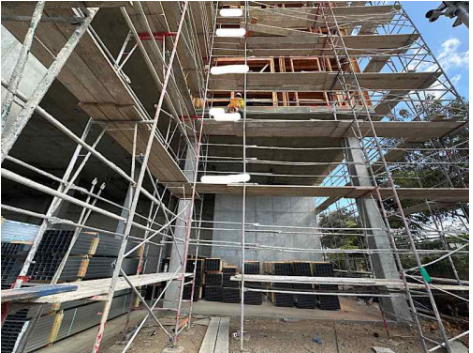
<b>Supported Scaffolding</b>		<b>Unsatisfactory</b>
<b>Comment</b>		
<p>Please ensure all scaffold sections above structure entrances are equipped with a toe board.</p>

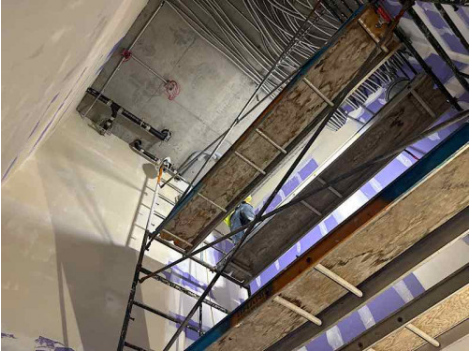
<b>Mobile Scaffolding</b>		<b>Unsatisfactory</b>
<b>Comment</b>		
<p>Sharp worker is working on a level that is not fully planked. The ladder should be used to access the working level. In addition the upper level must have a guard rail. Please ensure all working levels are fully planked.</p>

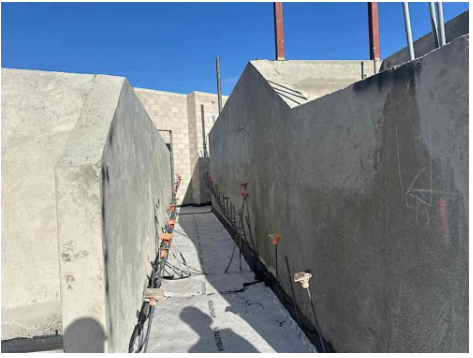
<p>Vertical rebar that must be protected with osha approved caps. Please ensure all vertical rebar is protected.</p>

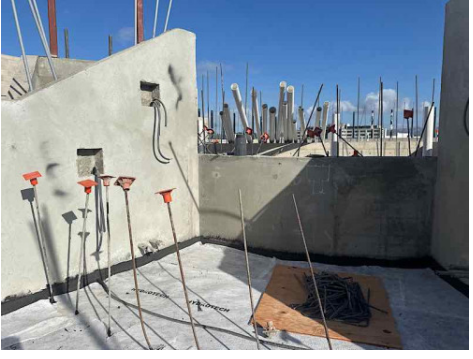
<p>Caps need to be maintained at all times by all trades.</p>

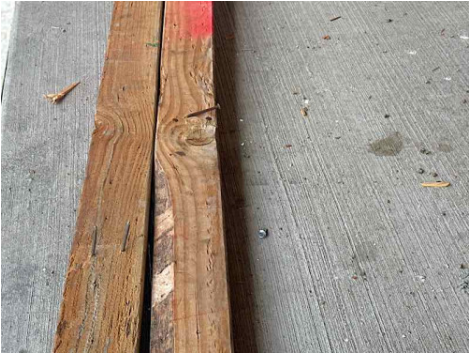
<p><b>Comment</b></p>	
<p>Housekeeping is in good order throughout the site. However guard rails that have been removed have nails sticking up. Please ensure all nails are removed or bent down.</p>

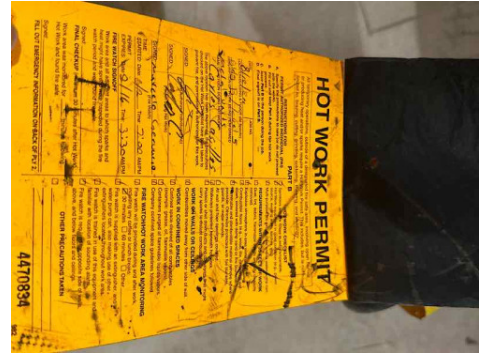
Please ensure hot work permits are filled out and keep up to date. Sharp

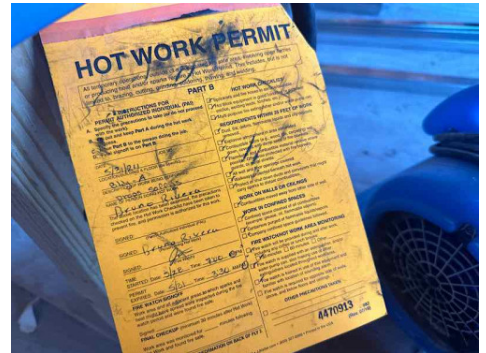
Please ensure hot work permits are filled out and keep up to date. The permit is expired. Sharp

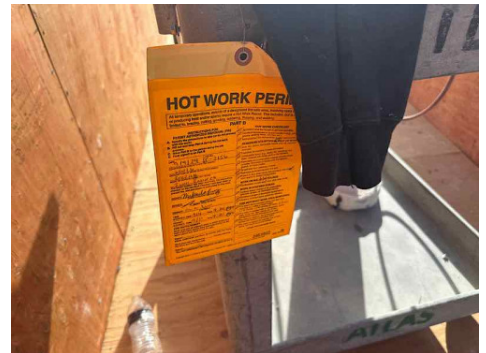
Please ensure hot work permits are filled out and keep up to date. The permit is expired. Atlas

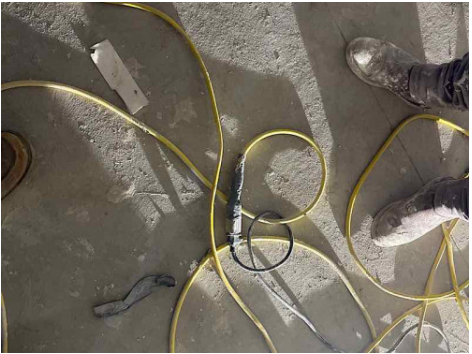
An electrical cord with damaged insulation is observed in the hallway on the third level. The cord must be removed and replaced. Please ensure cords are inspected prior to use. Sharp

<p>Same cord.</p>

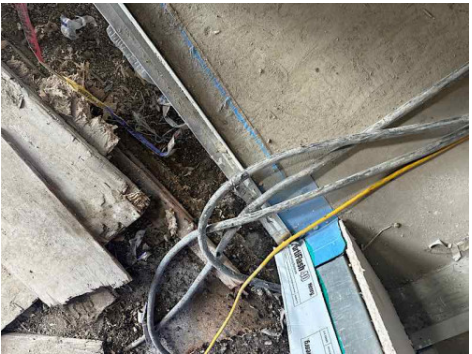
<p>Temporary leads have been fixed with electrical tape. Please ensure these are replaced as electrical tape is not approved for temporary extensions of power. Ground level near the elevator.</p>

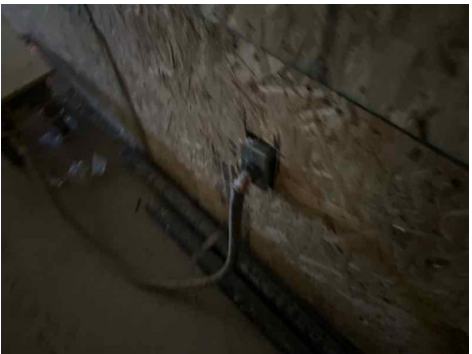
<p>The temporary cord has been damaged. Workers transporting materials must be careful not to damage temporary power extension cords. Near unit 433.</p>
