# SAFETY INSPECTION REPORT

**PROJECT:**  
Fullerton HUB

**INSPECTION TYPE:**  
General Construction

**INSPECTOR :** JUSTYN BLANCHARD  
**DATE :** JANUARY 06, 2025  
**CITY :** FULLERTON  
**STATE :** CA

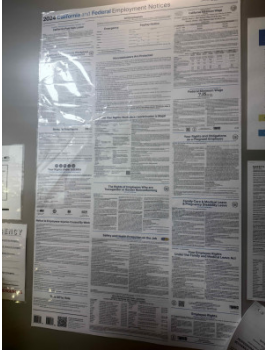
<b>Daily Inspections</b>		<b>Satisfactory</b>
<b>Comment</b>		
Being conducted daily.		-
<b>Tailgate Meetings</b>		<b>Satisfactory</b>
<b>Comment</b>		
Being conducted weekly.		-
<b>Sub-Contractor Meetings</b>		<b>Satisfactory</b>
<b>OSHA Permits</b>		<b>Satisfactory</b>
<b>Labor Law Postings</b>		<b>Satisfactory</b>
<b>Comment</b>		
Posted in the job office.

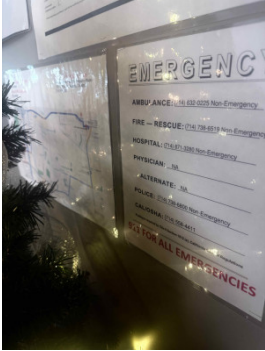
<b>Emergency / Other Postings</b>		<b>Satisfactory</b>
<b>Comment</b>		
Posted in the job site office.
