PROJECT INSPECTION

Company	Cencal Builders	Type of Inspection:	Cencal General Construction Inspection
Project	Amberline Apartments- Brentwood Ca	Date of Inspection	July 28, 2022
Inspector Name	veronica@cencal-builders.com	Time of Inspection	01:11 PM

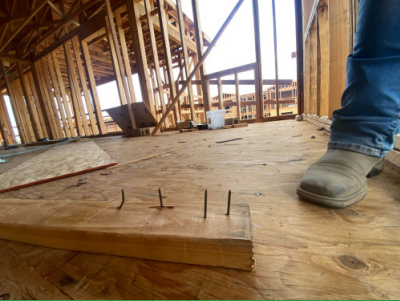
<p>Building 9- 3rd floor.Nails sticking up from 2x4 wooden board, needs to be hammered down to prevent a puncture by nails.</p> <p>Housekeeping- §1513. Housekeeping. (a) During the course of construction, alteration, or repairs, form and scrap lumber with protruding nails and all other debris shall be kept reasonably cleared from work areas, passageways, and stairs in and around buildings or other structures.</p>

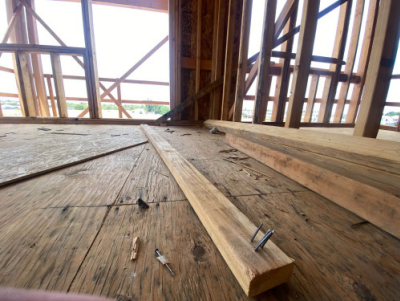
<p>Building 9- 3rd floor.Nails sticking up from 2x4 wooden board, needs to be hammered down to prevent a puncture by nails.</p> <p>Housekeeping- §1513. Housekeeping. (a) During the course of construction, alteration, or repairs, form and scrap lumber with protruding nails and all other debris shall be kept reasonably cleared from work areas, passageways, and stairs in and around buildings or other structures.</p>

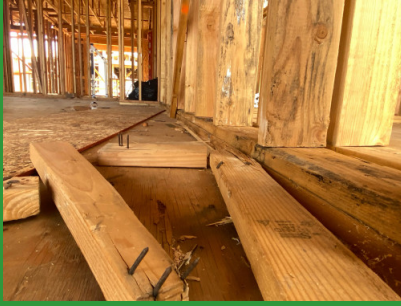
Building 9- 3rd floor.Nails sticking up from 2x4 wooden board, needs to be hammered down to prevent a puncture by nails.

Housekeeping- §1513. Housekeeping. (a) During the course of construction, alteration, or repairs, form and scrap lumber with protruding nails and all other debris shall be kept reasonably cleared from work areas, passageways, and stairs in and around buildings or other structures.

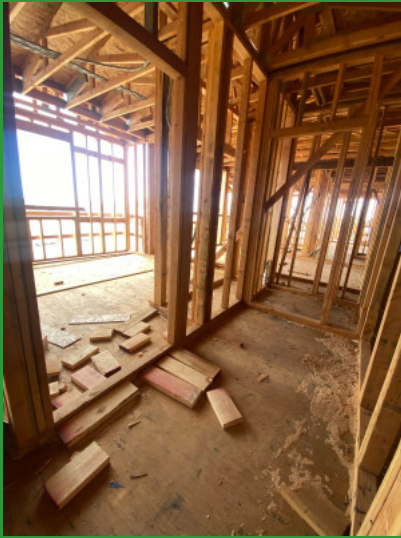
Building 9- 3rd floor. wooden blocks in front of access point. Walking area needs to be free from debris and materials.

Housekeeping- §1513. Housekeeping. (a) During the course of construction, alteration, or repairs, form and scrap lumber with protruding nails and all other debris shall be kept reasonably cleared from work areas, passageways, and stairs in and around buildings or other structures.

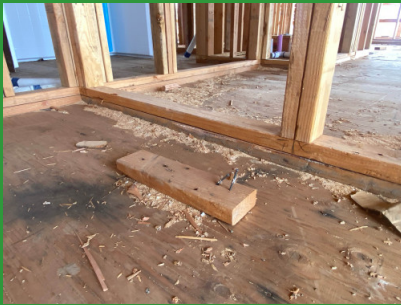
Building 10- 2nd & 3rd floor.Nails sticking up from 2x4 wooden board, needs to be hammered down to prevent a puncture by nails.

Housekeeping- §1513. Housekeeping. (a) During the course of construction, alteration, or repairs, form and scrap lumber with protruding nails and all other debris shall be kept reasonably cleared from work areas, passageways, and stairs in and around buildings or other structures.

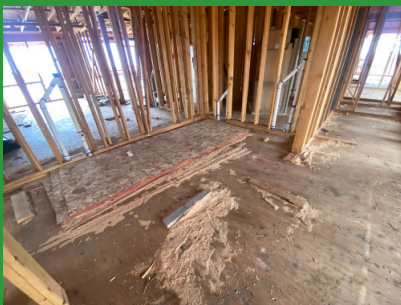
Building 9- 3rd floor wooden boards and blocks, needs to be pick up to prevent a slip, trip or fall hazard.

Housekeeping- §1513. Housekeeping. (a) During the course of construction, alteration, or repairs, form and scrap lumber with protruding nails and all other debris shall be kept reasonably cleared from work areas, passageways, and stairs in and around buildings or other structures.

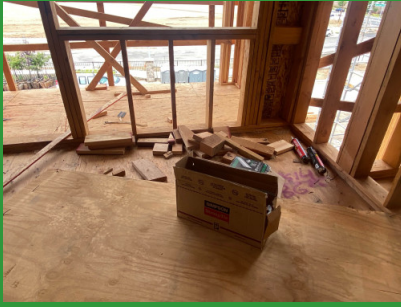
Building 9- 3rd floor wooden board needs to be pick up to prevent a slip, trip or fall hazard.

Housekeeping- §1513. Housekeeping. (a) During the course of construction, alteration, or repairs, form and scrap lumber with protruding nails and all other debris shall be kept reasonably cleared from work areas, passageways, and stairs in and around buildings or other structures.

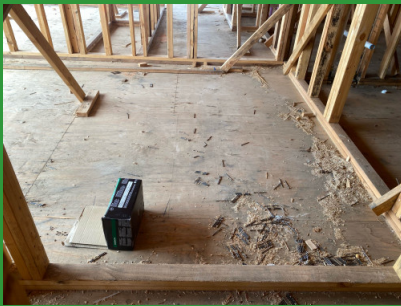
Building 9 & 10- 3rd floor nails on the floor. Need to be pick up can cause a punctured by nail. Serious hazard.

Housekeeping- §1513. Housekeeping. (a) During the course of construction, alteration, or repairs, form and scrap lumber with protruding nails and all other debris shall be kept reasonably cleared from work areas, passageways, and stairs in and around buildings or other structures.

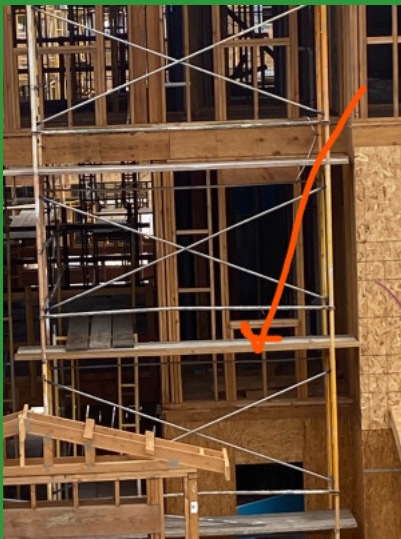
Building 8-2nd floor wooden board and blocks needs to be pick up to prevent a slip, trip or fall hazard.

Housekeeping- §1513. Housekeeping. (a) During the course of construction, alteration, or repairs, form and scrap lumber with protruding nails and all other debris shall be kept reasonably cleared from work areas, passageways, and stairs in and around buildings or other structures.

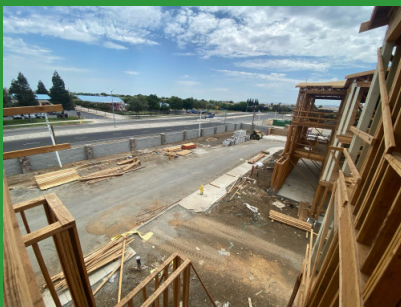
Building 9 & 10 - around and between buildings wooden board and blocks needs to be pick up to prevent a slip, trip or fall hazard. Poor housekeeping. Needs to get pick up before getting a report from GC.

Housekeeping- §1513. Housekeeping. (a) During the course of construction, alteration, or repairs, form and scrap lumber with protruding nails and all other debris shall be kept reasonably cleared from work areas, passageways, and stairs in and around buildings or other structures.
