PROJECT INSPECTION

Company	Helio	Type of Inspection:	SCC USE ONLY: General Contractor Review
Project	Arya	Date of Inspection	November 01, 2022
Inspector Name	Jeremy Chavez	Time of Inspection	09:00 AM

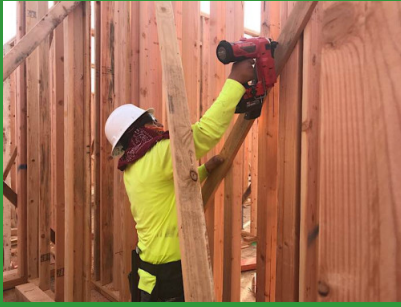
An employee is using a nail gun while his safety glasses are on his forehead.

The employee complied to don his safety glasses in the approved manner.

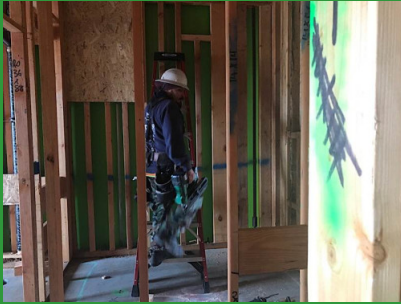
An employee was observed using a nail gun while not wearing his safety glasses.

The employee complied to don his safety glasses.

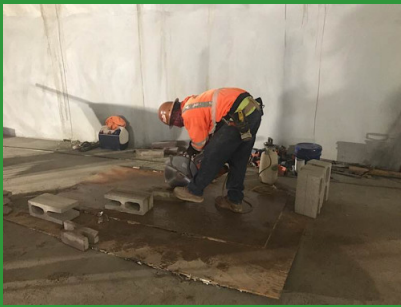
Employee is using a chop saw while not wearing his safety glasses.

The employee complied to don his safety glasses.

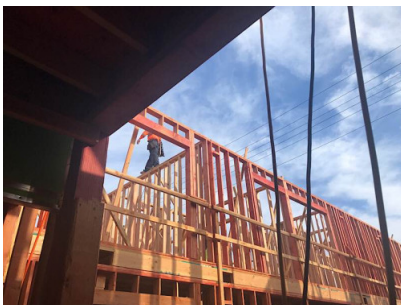
An employee was observed working within 6' of an unprotected edge while not wearing personal fall protection. The employee is well above his trigger height and was exposed to a significant fall hazard.

The employee will ensure a minimum 6' distance is maintained. The employee must use personal fall protection if he must perform a task within 6' of an unprotected edge that is above his trigger height.

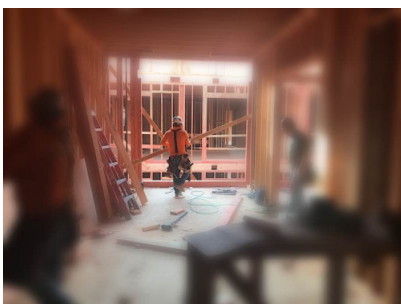
An employee is installing guardrails due to the height of the platform being above his trigger height for fall protection. The employee is not using personal fall protection while installing the guardrails.

Please ensure employees implement the use of personal fall protection when installing guardrails on a platform that is above their trigger height.

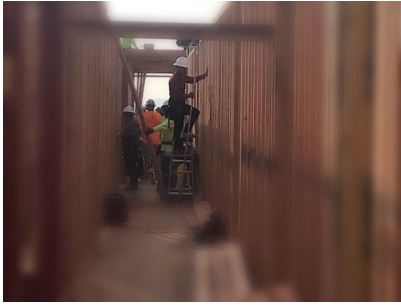
An employee is standing on the 2nd to top step of an A-Frame ladder.

Employees must use the approved steps of an A-Frame ladder. If the ladder is too short a taller ladder must be used.

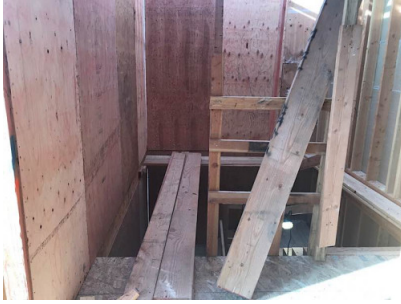
Two sets of stairs have not been completed to the top floor.

Two sets of stairs must be completed to the top floor prior to raising studs to the next floor.

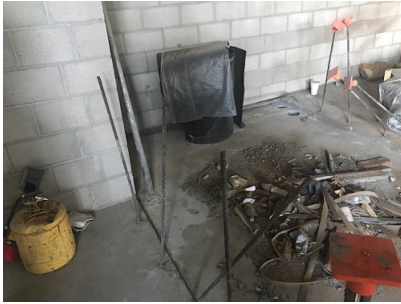
Rebar is uncapped leaving an exposed impalement hazard.

Please ensure rebar is capped or covered.

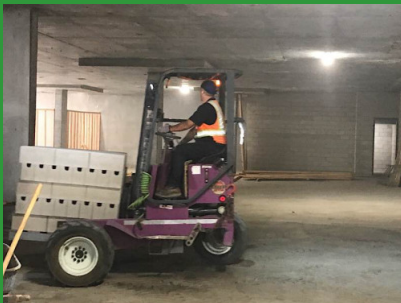
An employee is operating a forklift while not wearing his seatbelt.

Employee complied to secure his seatbelt.

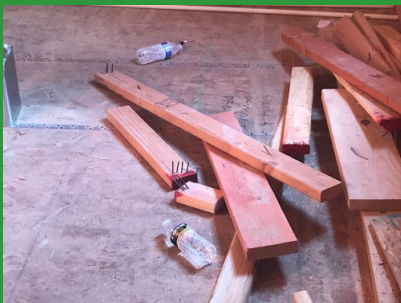
Nails in boards have not been bent down or removed.

Employees were assigned to bend the nails down.
