PROJECT INSPECTION

Company	Helio	Type of Inspection:	SCC USE ONLY: General Contractor Review
Project	Arya	Date of Inspection	July 25, 2022
Inspector Name	Jeremy Chavez	Time of Inspection	08:15 AM

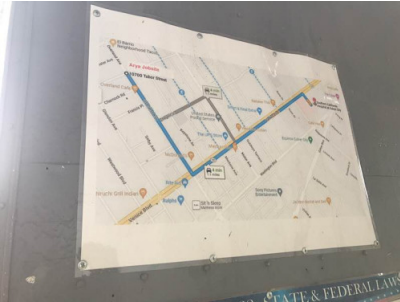
<p>Good job posting a map to the nearest medical facility. In addition to this map, an evacuation map is also required.</p>	<p>Please ensure the evacuation route is posted on site and updated as needed throughout project progress.</p>

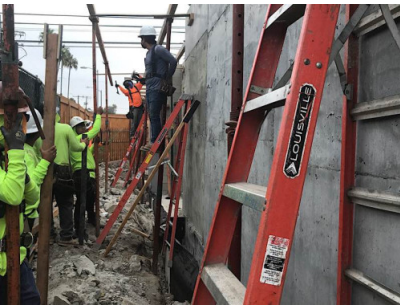
<p>A Mitchell employee is using an A-Frame ladder in a closed position. Another Mitchell employee is using an A-Frame ladder that is not level.</p>	<p>Please ensure employees use A-Frame ladders in an open, locked, and level position. Likely an extension ladder would be a better option for the circumstances pictured.</p>

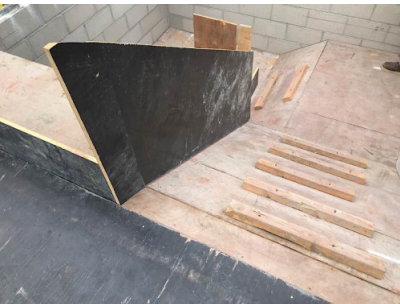
<p>This ramp exceeds the maximum angle allowed of 1 foot of rise for 12 feet of horizontal run.</p>	<p>It is recommended that scaffold stairs are installed in another location as concrete stairs will be to be poured in the area pictured. As a general reminder, 2 sets of stairs must be installed prior to raising studs to the 3rd floor.</p>

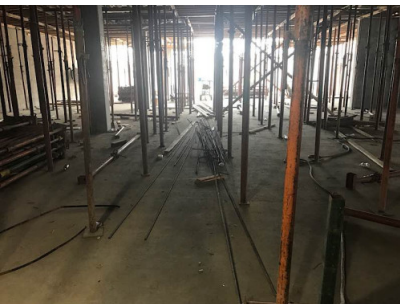
<p>Materials are being stored in a walkway.</p>	<p>The foreman assigned employees to move the materials. A path will be delineated using caution tape.</p>
