PROJECT INSPECTION

Company	Helio	Type of Inspection:	SCC USE ONLY: General Contractor Review
Project	Canfield	Date of Inspection	June 12, 2023
Inspector Name	Jeremy Chavez	Time of Inspection	01:38 PM

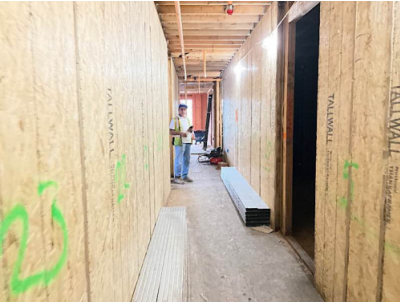
An employee is on site while not wearing a hard hat. Please ensure employees wear their hard hat while on site.

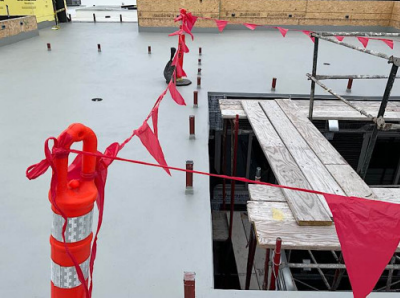
Please ensure flagged rope is a minimum of 6' back from the edge of the structure. As a general reminder, employees that work between the flagged rope and the edge must use personal fall protection.

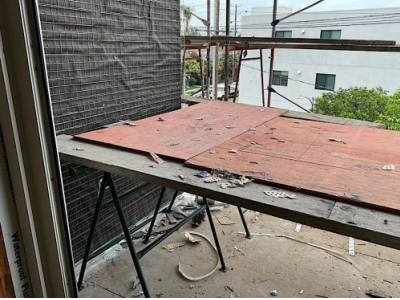
A few scaffold planks exceed the maximum 12" past the frame, which creates fall hazards. Please ensure planks are adjusted or supported.

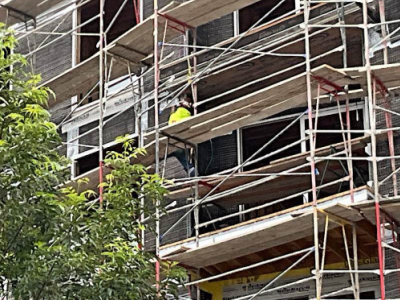
An employee is standing on two different sections of scaffold planks, which creates a fall hazard. Additional railing or planks must be installed.
