PROJECT INSPECTION

Company	Helio	Type of Inspection:	SCC USE ONLY: General Contractor Review
Project	Canfield	Date of Inspection	June 06, 2023
Inspector Name	Jeremy Chavez	Time of Inspection	08:53 AM

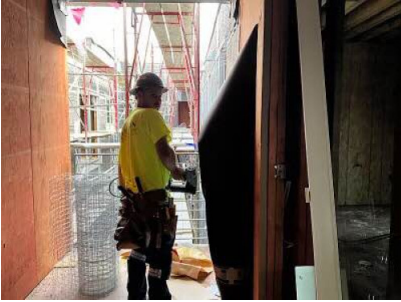
An employee is operating a nail gun while not wearing safety glasses. Please ensure employees wear safety glasses when required.

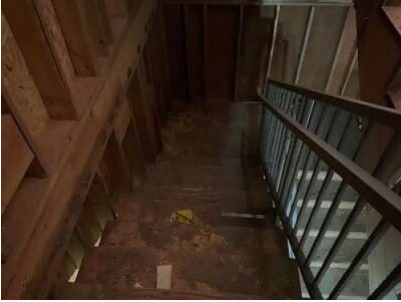
Illumination continues to be lacking in a section of stairs. Please ensure lighting is provided.

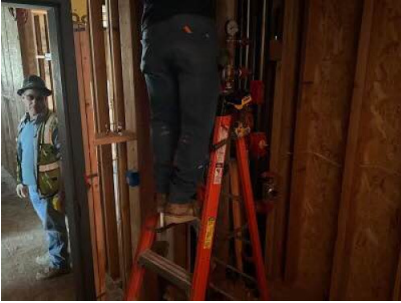
An employee was observed straddling an A frame ladder. The employee complied to use the approved steps, as seen in the picture.

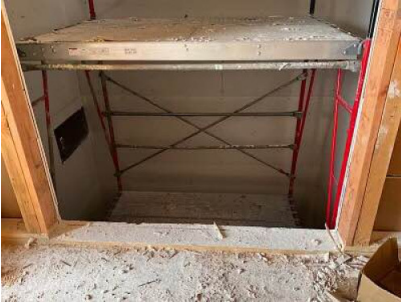
The scaffold planks exceed 24" in height difference from the structure walking platform and the wall opening is not otherwise protected. Please have guardrails installed.
