# PROJECT INSPECTION

<b>Company</b>	Helio	<b>Type of Inspection:</b>	SCC USE ONLY: General Contractor Review
<b>Project</b>	Venue	<b>Date of Inspection</b>	October 11, 2021
<b>Inspector Name</b>	Jeremy Chavez	<b>Time of Inspection</b>	11:27 AM

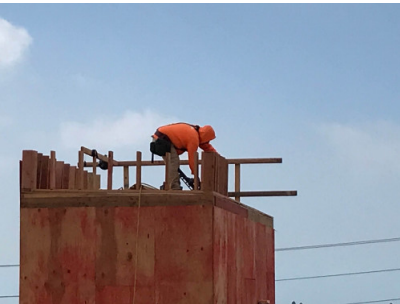
<p>Employee is using a nail gun while not wearing safety glasses. Additionally the employee is not wearing a hard hat, which is required while on the jobsite.</p>	<p>Please ensure employees wear the required PPE. Violations must be documented and disciplinary actions are required for repeat violations.</p>

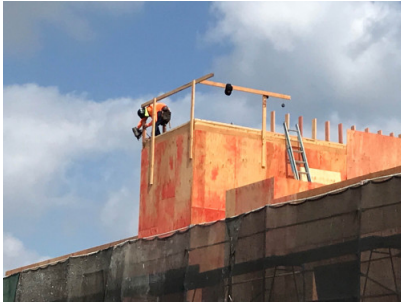
Employee is not using personal fall protection while working above his trigger height.

The employee is installing guardrails. During the installation process, personal fall protection must be implemented. Additionally, a written rescue plan is required.

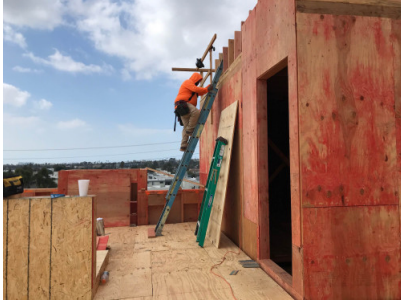
Access ladder has not been secured at the top from tipping or falling.

Please ensure access ladders are secured from tipping or falling.

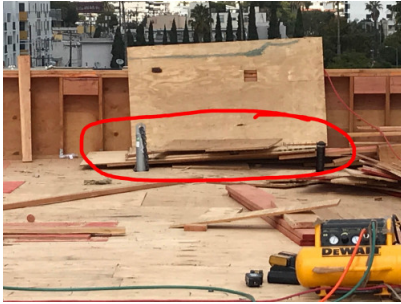
Nails in boards are not bent down or removed.

Please ensure nails in boards are bent down or removed.
