PROJECT INSPECTION

Company	Helio	Type of Inspection:	SCC USE ONLY: General Contractor Review
Project	Venue	Date of Inspection	October 19, 2021
Inspector Name	Jeremy Chavez	Time of Inspection	07:24 AM

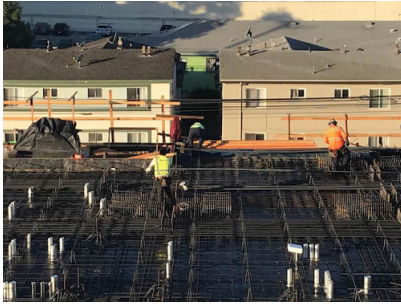
Employee is working above his trigger height while a means of fall protection is not provided.

Please ensure the required guardrails are installed.

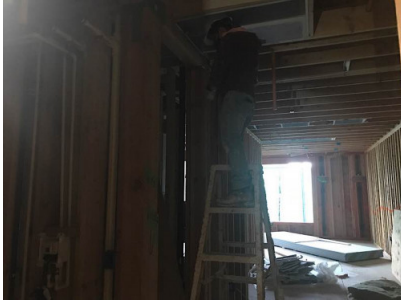
Employee is straddling an A-Frame ladder.

Employee will obtain a taller ladder and use only the approved steps.

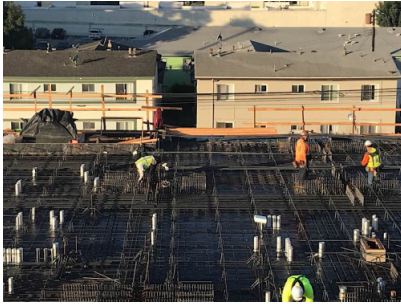
Distance is not a means of fall protection.

Guardrails must be installed in loading/unloading zones. A means of fall protection must be provided while loading or unloading tools and materials.
