PROJECT INSPECTION

Company	Helio	Type of Inspection:	SCC USE ONLY: General Contractor Review
Project	Venue	Date of Inspection	December 07, 2021
Inspector Name	Jeremy Chavez	Time of Inspection	08:50 AM

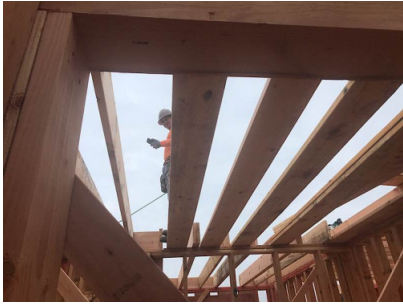
Employee was using a nail gun while not wearing safety glasses.

Employee went to his foreman to obtain another pair of safety glasses.

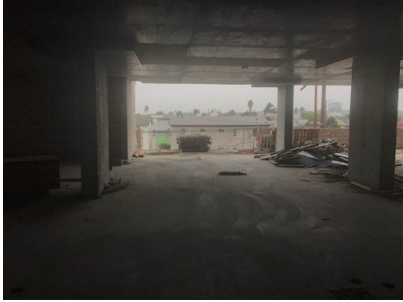
This loading/unloading zone does not have a physical barrier to protect against falls.

Please ensure the physical barrier is provided.

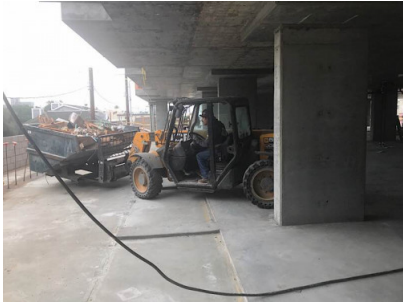
Employee is operating a reach lift while not wearing his seatbelt.

Employee secured his seatbelt.

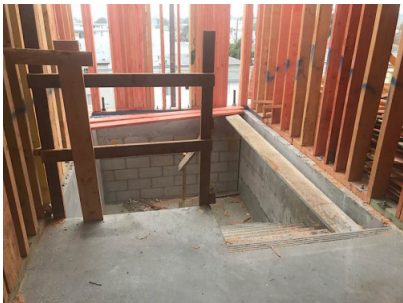
Makeshift scaffolding is not approved for use.

Please ensure only approved scaffolding or means of gaining elevation are installed.
