# PROJECT INSPECTION

<b>Company</b>	Helio	<b>Type of Inspection:</b>	SCC USE ONLY: General Contractor Review
<b>Project</b>	Venue	<b>Date of Inspection</b>	March 21, 2022
<b>Inspector Name</b>	Jeremy Chavez	<b>Time of Inspection</b>	11:00 AM

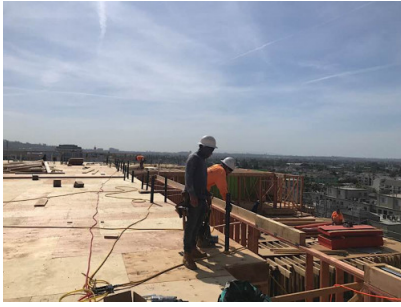
Employee in the foreground was observed using a skill saw while not wearing safety glasses.

Employees must wear ANSI rated safety glasses when operating power tools.

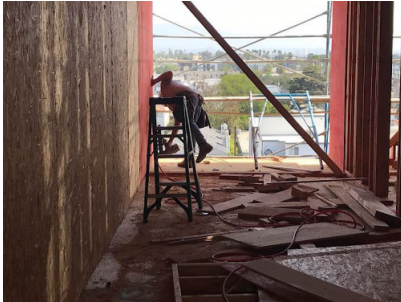
Employee is using a nail gun while not wearing safety glasses.

Employees must wear their safety glasses while using a nail gun.

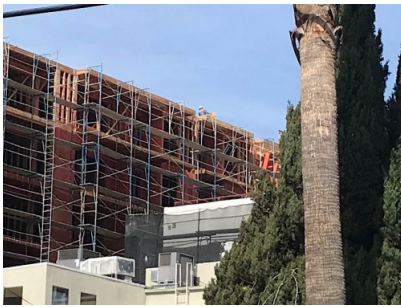
Employee is working above his trigger height and exposed to a significant fall hazard.

Employees must have a means of fall protection, such as personal fall protection. Alternatively guardrails may be installed. Employees are in the process of installing guardrails, however have not completed the installation on this level. As a note, employees installing railing will need to use personal fall protection.

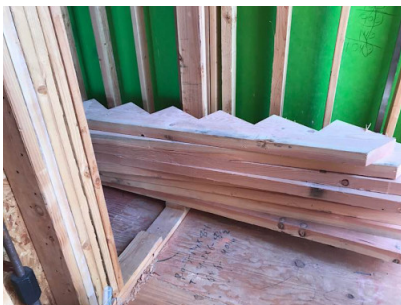
Stairs have not been installed to the top floor which creates an access issue in the event of an emergency.

As pictured, the stairs are in the process of being installed. Please ensure this is provided as soon as possible.

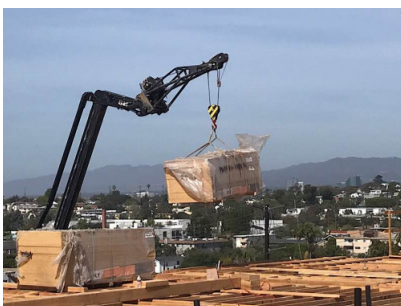
Employees are hoisting materials while a tag line is not in use.

Loads must have a tagline to prevent twisting, turning, or tipping, especially consider wind conditions today.
