PROJECT INSPECTION

Company	Helio	Type of Inspection:	SCC USE ONLY: General Contractor Review
Project	Venue	Date of Inspection	March 07, 2022
Inspector Name	Jeremy Chavez	Time of Inspection	09:05 AM

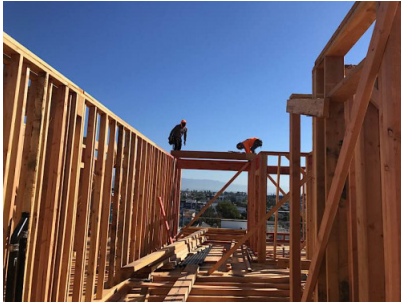
Employees are working above their trigger height and within 6' of an unprotected edge. This exposes both employees to a very significant fall hazard.

The employees complied to work in an area that did not expose them to the fall hazard. The employees will use personal fall protection when work resumes in the area pictured.

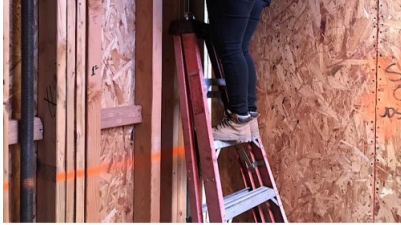
Employee is working on an A-Frame ladder that is in a closed position.

The employee complied to open the ladder so it may be used in an open, locked, and level position.

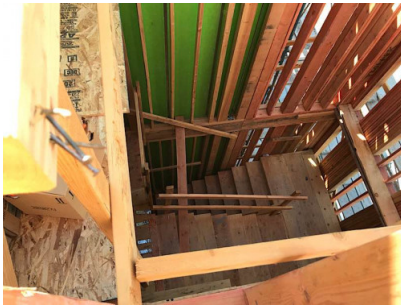
Stairs have not been completed to the top floor. Currently, an access ladder is the only means of access to the top level.

The superintendent contacted the framing foreman in order to ensure this is made a priority for install.
