PROJECT INSPECTION

Company	Helio	Type of Inspection:	SCC USE ONLY: General Contractor Review
Project	Venue	Date of Inspection	July 21, 2022
Inspector Name	Jeremy Chavez	Time of Inspection	08:15 AM

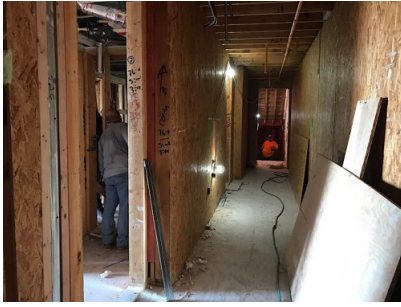
Several employees do not have the required PPE donned, which includes their hard hat.

Employees were reminded that a hard hat, safety glasses, and hi vis apparel are jobsite requirements. Employees stopped work to obtain the needed PPE.

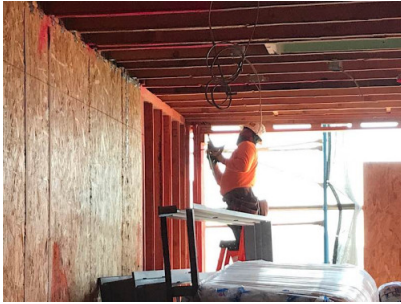
Employee is using a nail gun while not wearing safety glasses.

The employee complied to don his safety glasses.

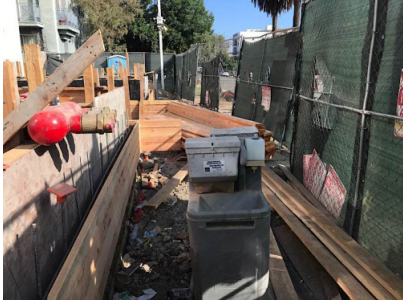
Housekeeping in the pictured area needs to give attention to materials and debris in a walkway.

Please ensure a clear walkway is maintained in the area pictured.
