PROJECT INSPECTION

Company	Helio	Type of Inspection:	SCC USE ONLY: General Contractor Review
Project	Venue	Date of Inspection	July 05, 2022
Inspector Name	Jeremy Chavez	Time of Inspection	11:20 AM

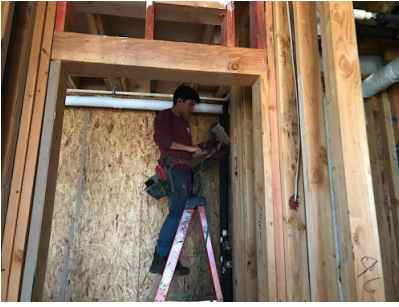
Employee is using a nail gun while not wearing his safety glasses.

Please ensure employees wear ANSI Z87 safety glasses while using power tools, such as a nail gun.

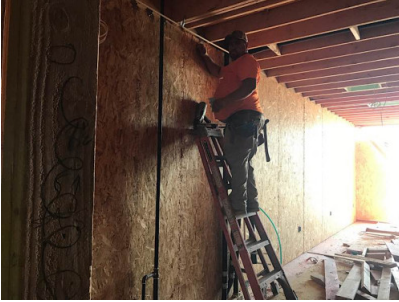
Employee is using an A-Frame ladder in a closed position, which is prohibited. The employee is also using a nail gun while not wearing safety glasses.

Please ensure employees wear ANSI Z87 safety glasses while using power tools. The employee complied to use the ladder in an open, locked, and level position.

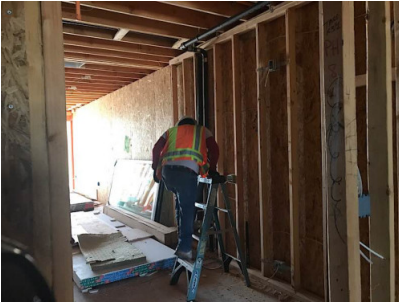
The pictured employee was observed standing on the top cap of an A-Frame ladder.

Please ensure employees use only the approved steps of ladders, which may require using a taller ladder.

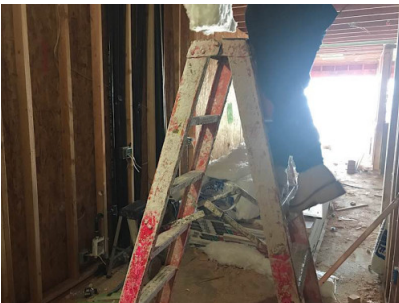
Employee is using a ladder that is not fully open and locked. The employee was observed straddling the ladder, which is prohibited.

The employee complied to open and lock the ladder as well as use only the approved steps.

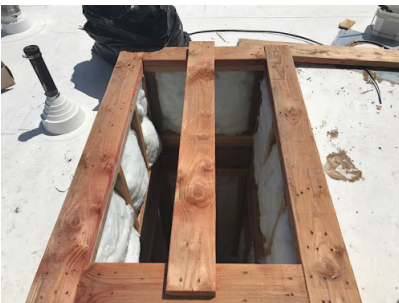
The pictured opening is not fully covered, secured, and marked "OPENING DO NOT REMOVE".

An employee was immediately assigned to fully cover, secure, and mark the opening with "OPENING DO NOT REMOVE".

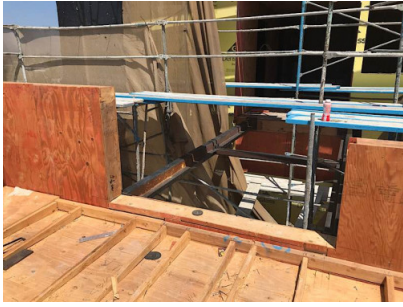
Railing is lacking in a section where scaffolding exceeds 16" from the structure.

An employee was immediately assigned to install the required railing.

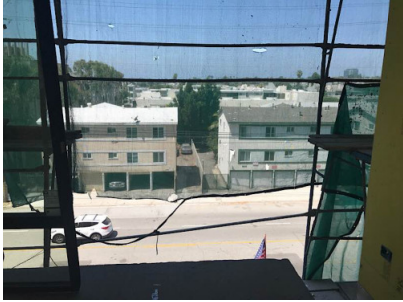
A section of scaffolding was removed to complete a task, which now exposes a significant fall hazard due to missing planks and railing.

The superintendent immediately assigned employees to ensure the required planks and railing were reinstalled.
