PROJECT INSPECTION

Company	Helio	Type of Inspection:	SCC USE ONLY: General Contractor Review
Project	Venue	Date of Inspection	January 10, 2022
Inspector Name	Jeremy Chavez	Time of Inspection	08:10 AM

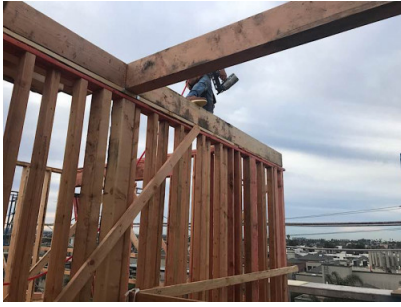
Employee was observed using a nail gun while not wearing safety glasses.

Employee has non safety rated sunglasses and will need to obtain safety glasses.

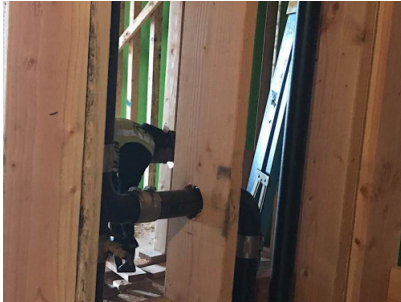
Employee is using a skill saw while not wearing safety glasses.

Employee donned safety glasses.

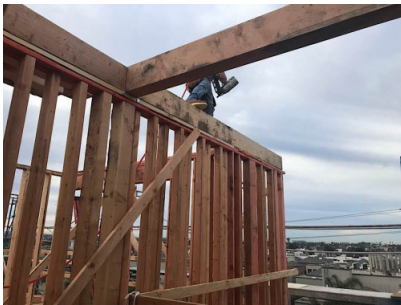
Employee is working above his trigger height and is exposed to a significant fall hazard.

Please ensure employees use personal fall protection when working above their trigger height.

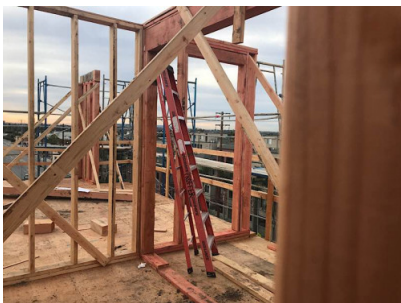
An A-Frame ladder is being used in a closed position and as an access ladder.

Please ensure appropriate access is set up.

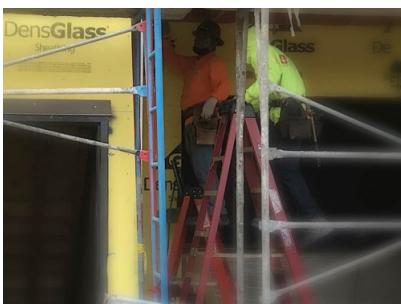
Employee is standing on the 2nd to top step of an A-Frame ladder.

Employee complied to use only the approved steps.

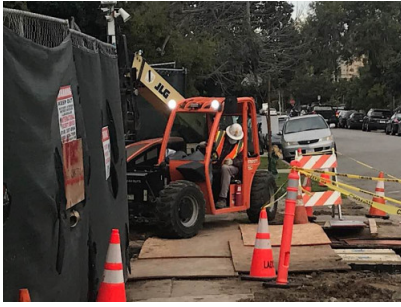
Employee is operating a reach lift while not using his seatbelt.

Employee complied to secure his seatbelt.
