# SAFETY INSPECTION REPORT

**CONDUCTED FOR:**  
DBKO Design and Build

**PROJECT:**  
Simi Valley Waste Management RNG

**INSPECTION TYPE:**  
General Construction

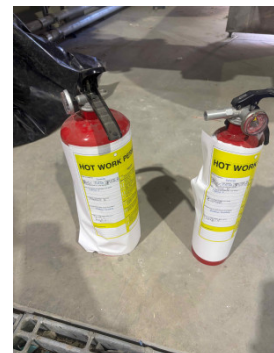
Photo 1: All hot work fire extinguishers seen have been inspected with an expiration date of 2/11/25.

There are fire extinguishers at each hot work station.

It is recommended to have at minimum a 10 pound fire extinguisher for the environment in which hot work is being performed.

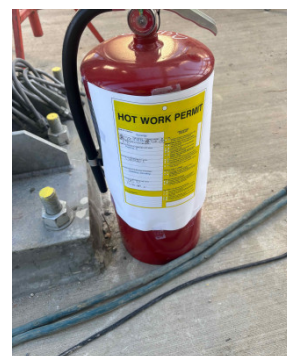
Photo 2: Please ensure that when doing daily inspections of the fire extinguishers, there is a pin in place. These pins can fall out with ease.

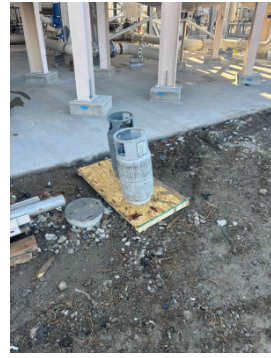
Photo 1: A liquid petroleum cylinder was seen in the indicated spot on the photo. Although it was empty, please ensure these are properly stored as well as 25 feet away from any hot work. Please inspect every area used for hot work for combustible materials like this. This was corrected instantly.

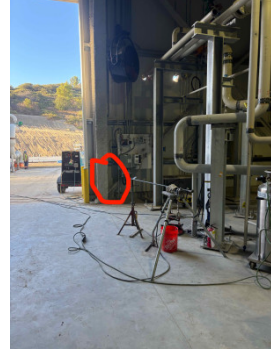
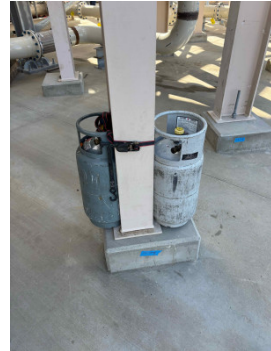
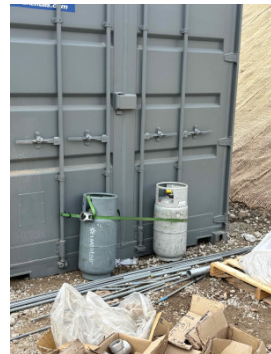
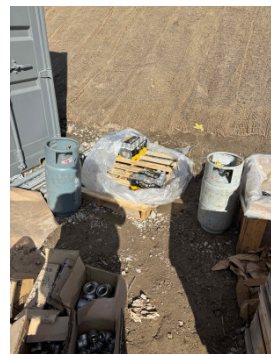
Photos 2 through 5: Please make sure liquid petroleum cylinders are properly stored and secured even if they are empty. There were multiple cases. Each case was corrected immediately.

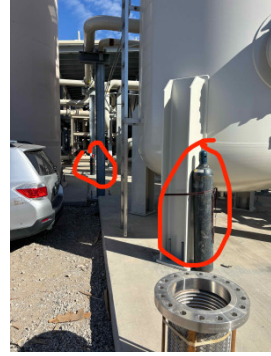
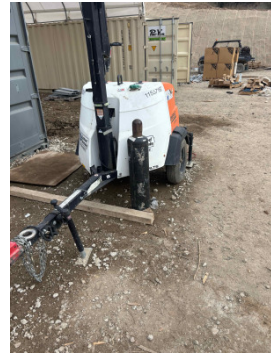
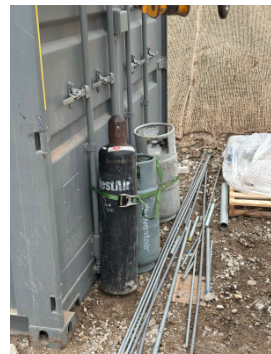
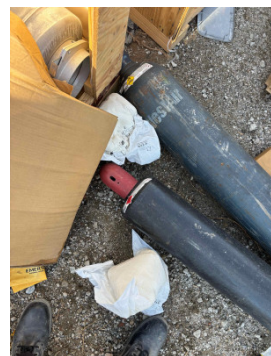
Photos 1 through 4: Even if considered empty, please store oxygen and flammable gas cylinders upright, secured, and 20 feet apart. Acetylene is able to be stored with liquid petroleum. This was corrected immediately.

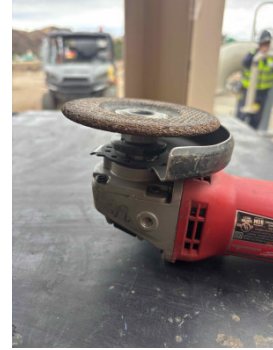
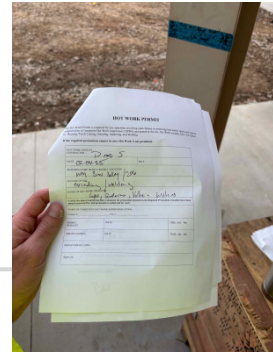
Photo 1 and 2: Please ensure all hot work permits are filled out completely and signed by the supervisor each morning before hot work begins.

Great job having hot work permits available for request. Again, please ensure to fill them out completely and have them signed before performing any hot work.

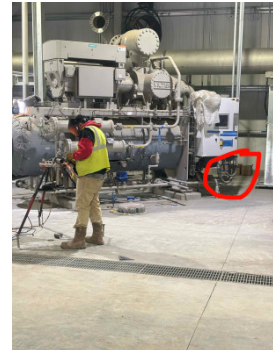
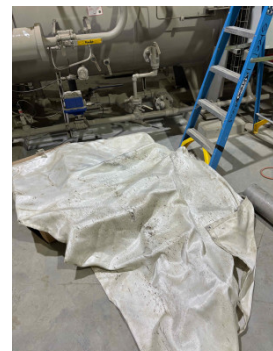
Photo 3 and 4: Each of these photos shows the corrective action taken, but please make sure to inspect areas in which hot work is being performed for combustible materials. All situations seen were fixed.
