SAFETY INSPECTION REPORT

CONDUCTED FOR:
DBKO Design and Build

PROJECT:
Simi Valley Waste Management RNG

INSPECTION TYPE:
General Construction

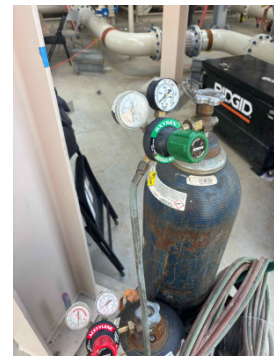
Photo 1: Please purchase a new gauge. Gauge seen in photo is missing a cover.

Please ensure that cylinders being used are stored and secured properly with a 20 foot separation between oxygen and acetylene at the end of the day.

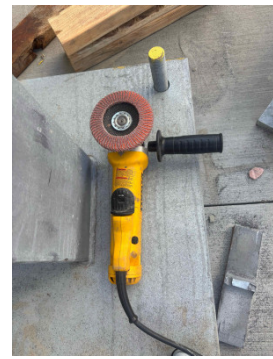
Photo 1: Please ensure all hot work permits are filled out completely and signed before hot work begins each morning. Please make sure that each hot work permit covers the 20 foot radius as discussed.

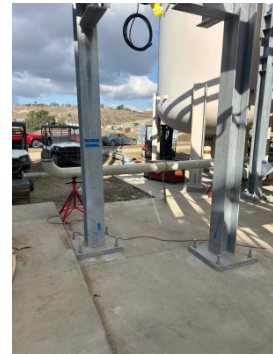
Photo 2: Please inspect working areas for hazards when performing hot work. This was corrected immediately.

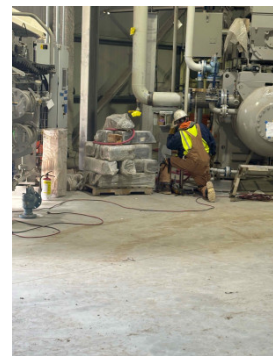
Photo 3: Please make sure there is a fire extinguisher at each hot work station and that fire extinguishers are not being shared between hot work stations.
