# SAFETY INSPECTION REPORT

**CONDUCTED FOR:**  
Pacific Hydrotech Corporation

**PROJECT:**  
Golf Club Sewer LS

**INSPECTION TYPE:**  
General Construction

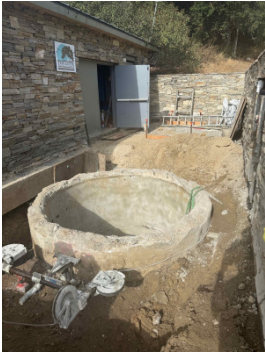
**Fall Protection**

<b>Comment</b>	<b>Unsatisfactory</b>
<p>Work is being done cutting the top of this hole with a steel cable. This hole is about 30' deep exposing employees to a serious fall. Employees were walking around the hole to get to the building as it's the only means of access. It was discussed with Robert about this and he said that they guys will not be working in the building anymore and also there will be a delineation line in between the employees and the fall hazard. It usually covered by a steel plate.</p>
