# SAFETY INSPECTION REPORT

**CONDUCTED FOR:**  
Thomas James Homes: NorCal

**PROJECT:**  
976 Lincoln Court San Jose

**INSPECTION TYPE:**  
General Construction

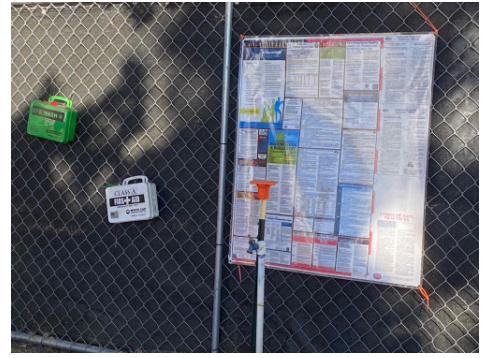
<b>Labor Law Postings</b>	<b>Satisfactory</b>
---------------------------	---------------------

Good job having these in place on the fence.

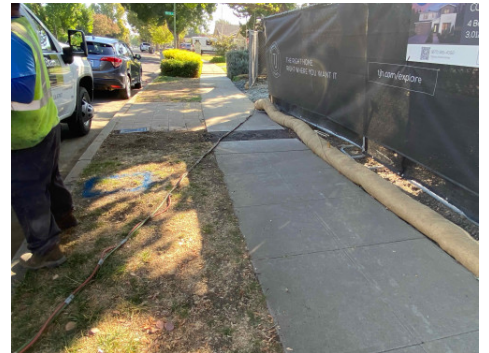
**Access / Egress**

- Blazona had hose running across the sidewalk without any protection in place. This was trip hazard for pedestrians and workers. Corrected on site.

Blazona Concrete with an unmarked trip hazard going over the sidewalk where pedestrians walk and trades enter the site. Corrected on site.

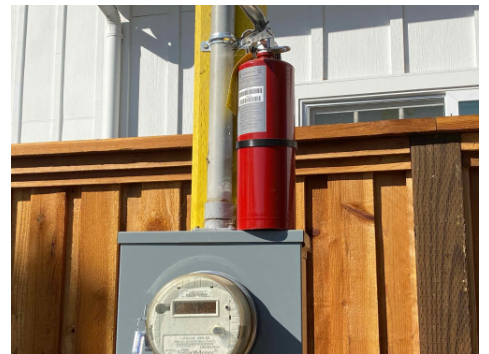
**Fire Extinguisher(s)**

Fire extinguisher is on the electrical panel.

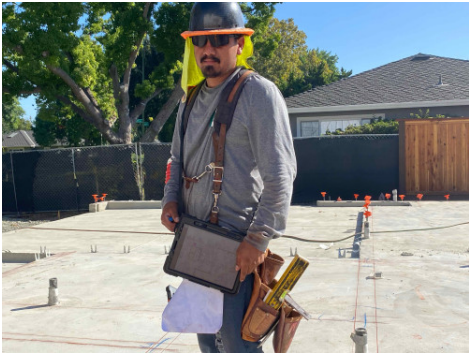
<b>Personal Protective Equipment</b>	<b>Satisfactory</b>
<b>Comment</b>	
No concerns observed.	-

Good job by Timberworks.

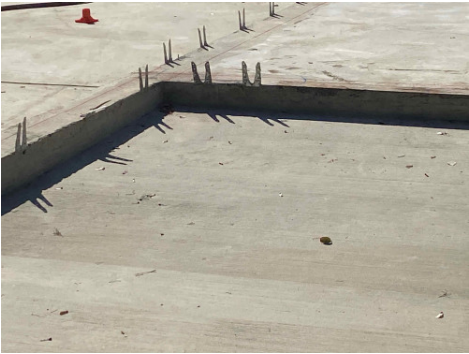
<b>Impalement Hazards</b>	<b>Unsatisfactory</b>
---------------------------	-----------------------

- Metal ties are an impalement hazard.
- Nails sticking out of the foundation pose an impalement hazard.

<p>Metal ties pose a hazard. Ensure they are protected.</p>

Note: Cal Osha mentions the following: "Protection from Reinforcing Steel and Other Similar Projections. (1) Employees working at grade or at the same surface as exposed protruding reinforcing steel or other similar projections, shall be protected against the hazard of impalement by guarding all exposed ends that extend up to 6 feet above grade or other work surface, with protective covers, or troughs.

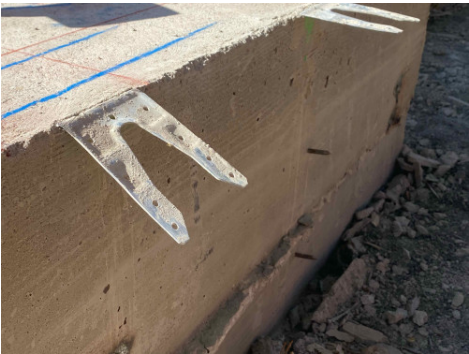
<p>Nail sticking out of the foundation or a hazard. Ensure they are bent over or cut off.</p>

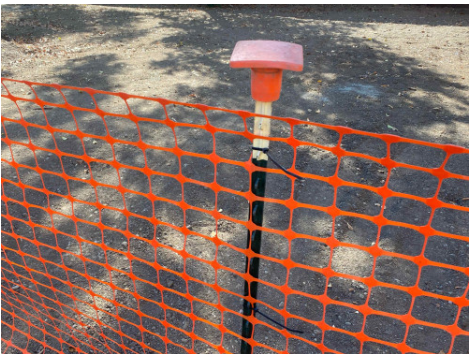
<p>Good job protecting fence posts.</p>

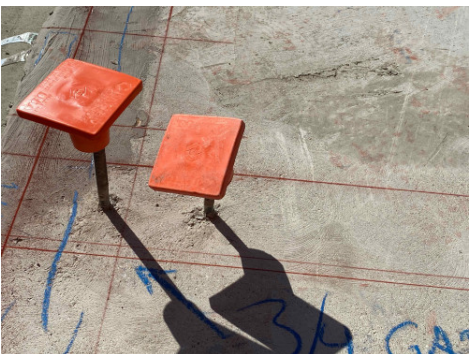
<p>Good job protecting anchors in the foundation.</p>

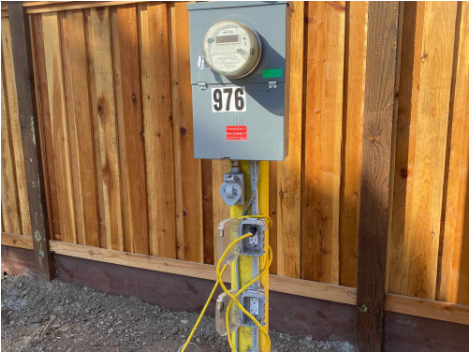
<b>Electrical Safety</b>	<b>Satisfactory</b>
--------------------------	---------------------

Comment	
No concerns observed. All covers are in place.
