# SAFETY INSPECTION REPORT

**CONDUCTED FOR:**  
West Builders, Inc.

**PROJECT:**  
Fullerton HUB

**INSPECTION TYPE:**  
General Construction

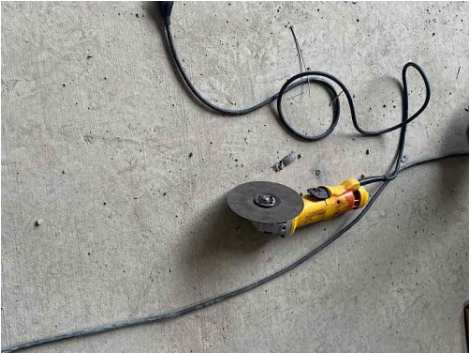
<b>Power Tools</b>		<b>Unsatisfactory</b>
<b>Comment</b>		
<p>An employee has a grinder that does not have its guard equipped. The employee complied to secure the guard.</p>

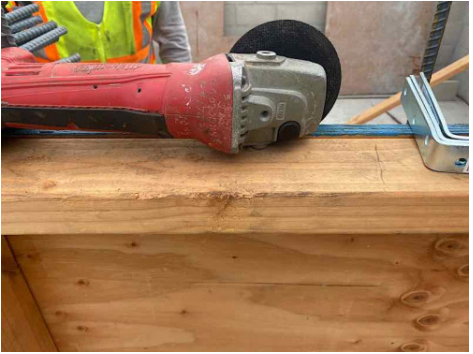
<p>Another employee has a grinder that does not have its guard equipped. The employee complied to secure the guard.</p>

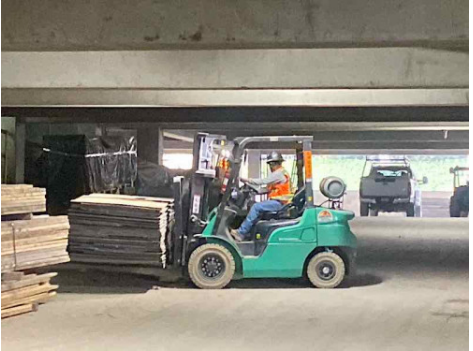
<b>Powered Industrial Trucks</b>		<b>Unsatisfactory</b>
<b>Comment</b>		
<p>An employee is operating a forklift while not wearing his seatbelt. The employee complied to secure his seatbelt.</p>

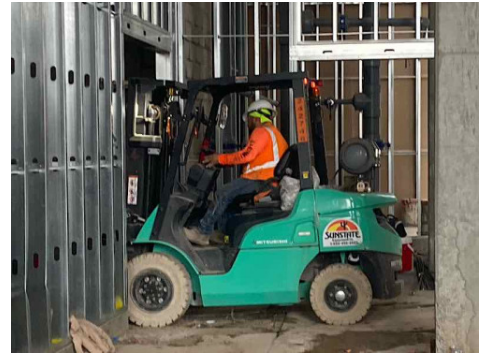
Another employee is operating a forklift while not wearing his seatbelt. The employee complied to secure his seatbelt.

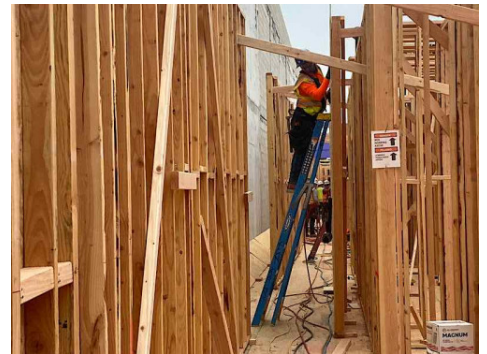
A Trademark employee is using an A-Frame ladder in a closed position. Please ensure employees use ladders in an open, locked, and level position. Alternatively, a lean-safe ladder may be used.

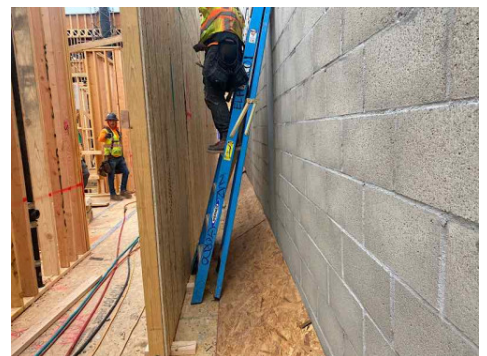
Another Trademark employee is using an A-Frame ladder in a closed position. Please ensure employees use ladders in an open, locked, and level position. Alternatively, a lean-safe ladder may be used.

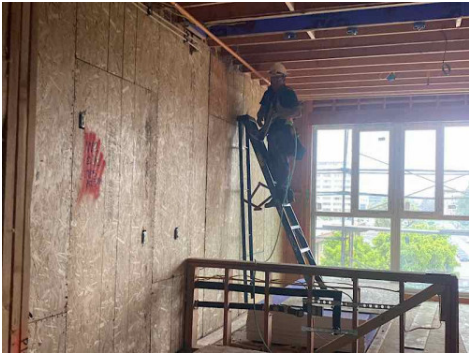
One more Trademark employee is using an A-Frame ladder in a closed position. Please ensure employees use ladders in an open, locked, and level position. Alternatively, a lean-safe ladder may be used.

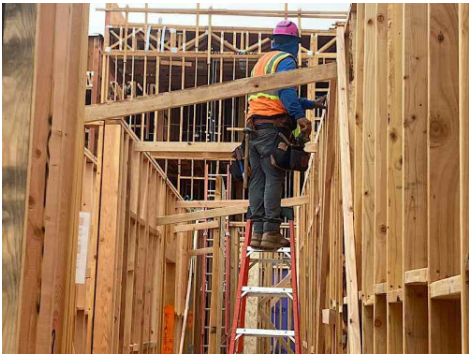
A Trademark employee is standing on the 2nd to top step of an A-Frame ladder. Please ensure employees use the approved steps of a ladder.

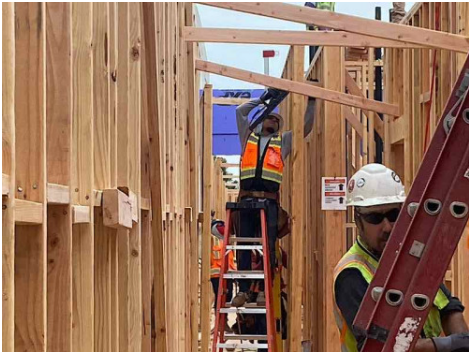
A Trademark employee is using a nail gun while not wearing safety glasses. Please ensure employees wear the required PPE.

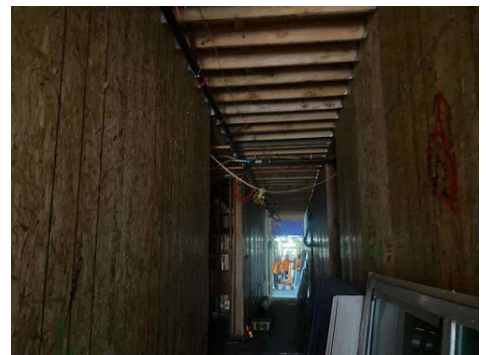
There were a few areas that were lacking sufficient illumination. Please ensure employees are provided with sufficient lighting.
